## EDC 12: Barraston Quarry, Barraston Farm

**Date visited:** 9th March 2009

### Summary description

Disused mudstone quarry, formerly used for the manufacture of bricks.

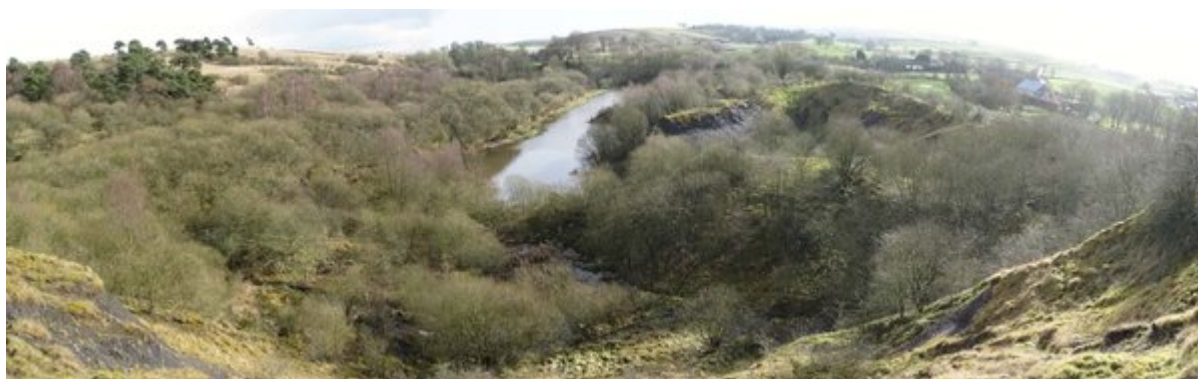
**Current condition** Many of the quarry faces are well degraded

(Photo 55) Panorama across the old workings of Barraston Quarry, now partly flooded. Unfortunately only small degraded exposures remain and access is difficult through dense woodland which reduces the potential value of the site. Rating: 4.

(Photo 55) Panorama across the old workings of Barraston Quarry, now partly flooded. Unfortunately only small degraded exposures remain and access is difficult through dense woodland which reduces the potential value of the site.

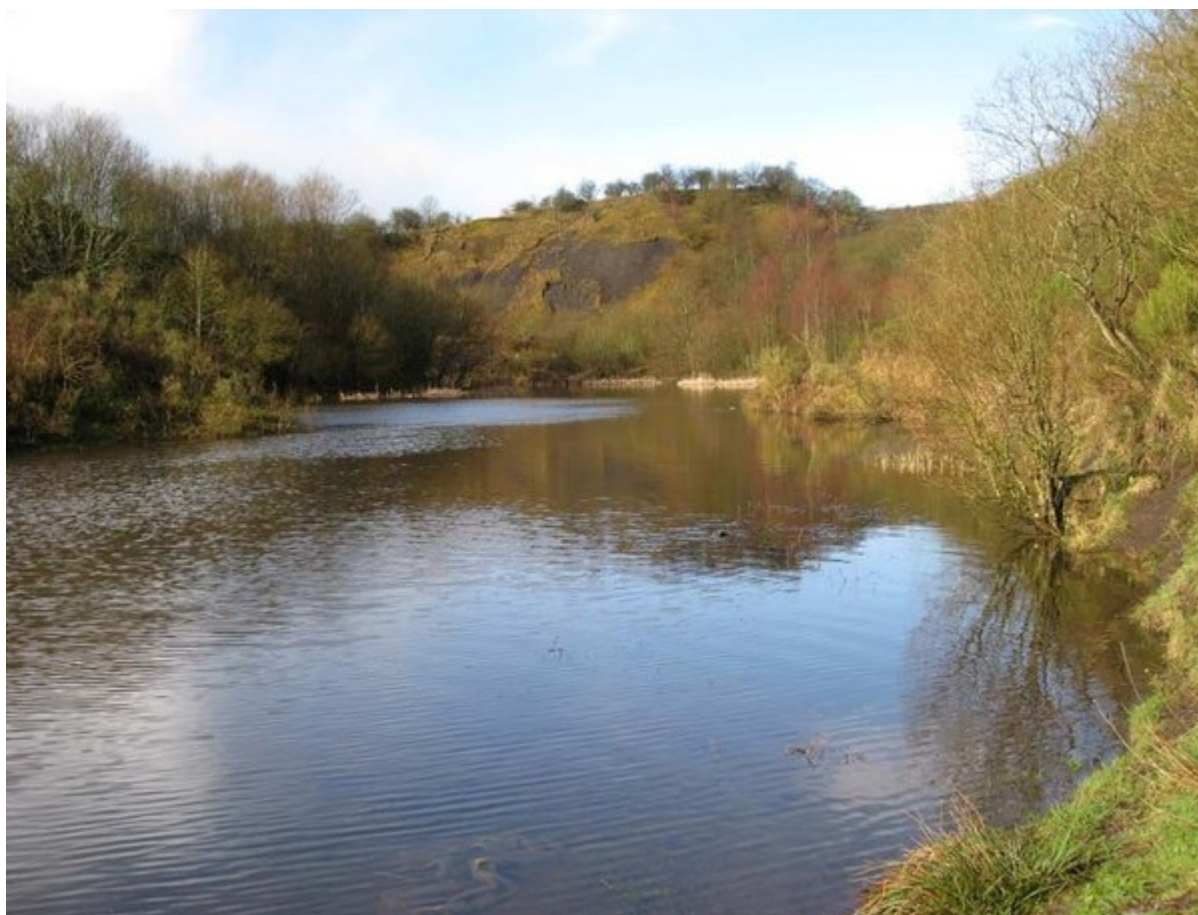
(Photo 56) View WNW along the flooded part of Barraston Quarry.

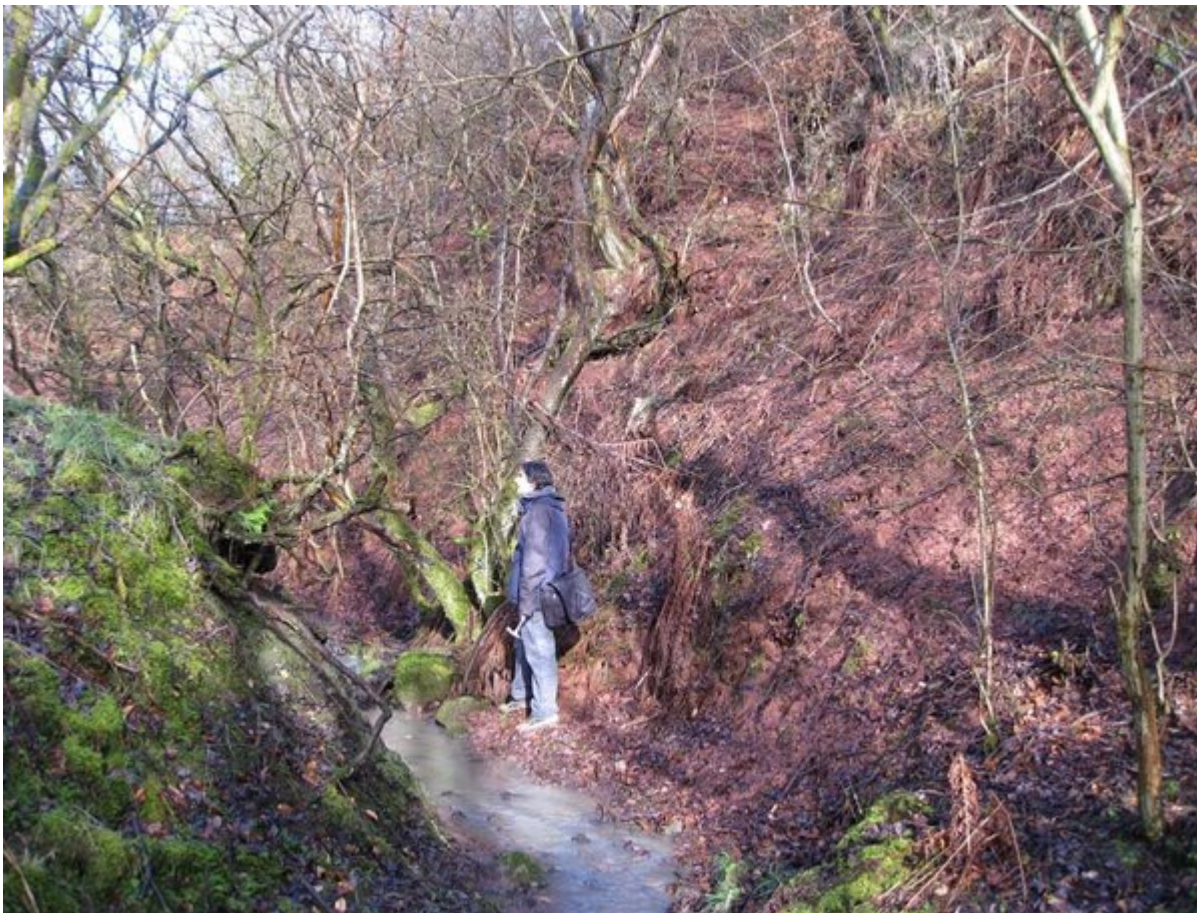
(Photo 57) Burnt shale waste piles are found to the north of the quarry. Looking NW.

*(Photo 57) Burnt shale waste piles are found to the north of the quarry. Looking NW.*

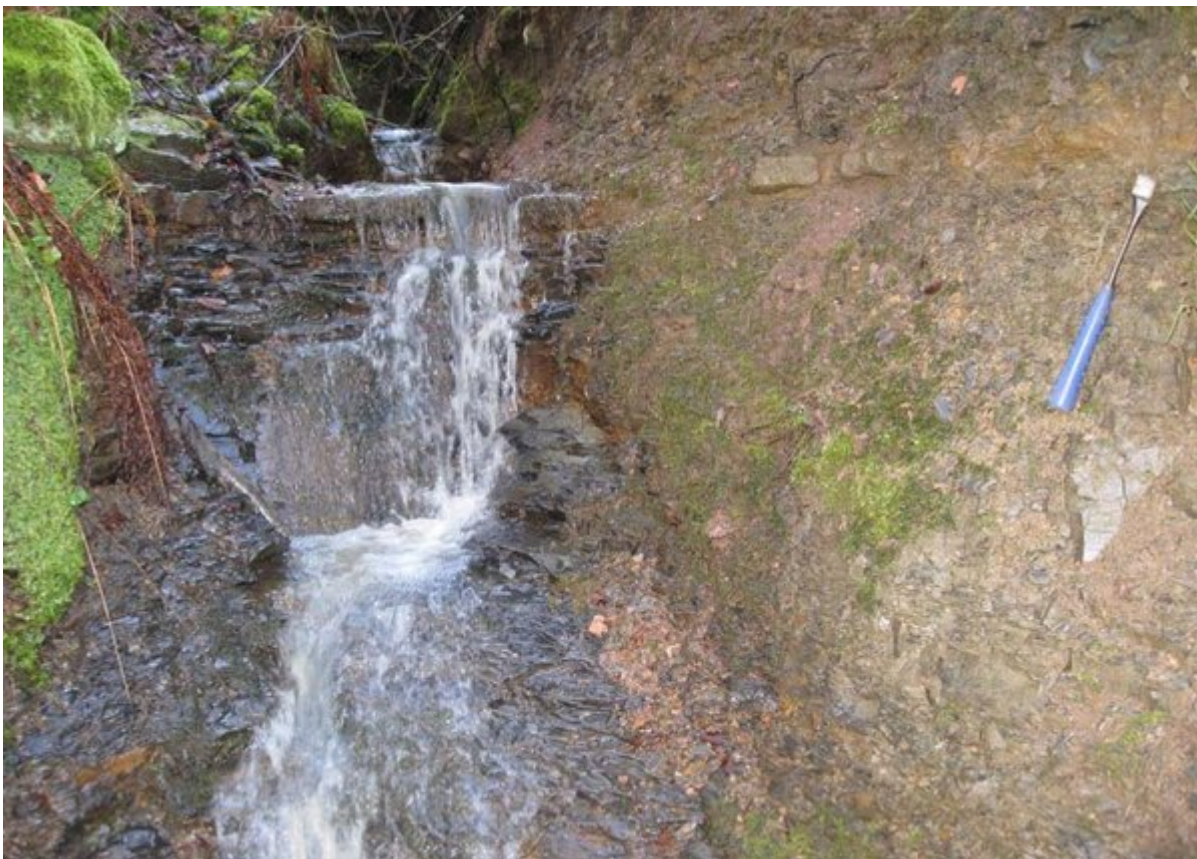
(Photo 58) An ironstone band forms a resistant horizon within the layers of laminated black mudstones, creating a lip for a small waterfall. Looking SW.

*(Photo 58) An ironstone band forms a resistant horizon within the layers of laminated black mudstones, creating a lip for a small waterfall. Looking SW.*

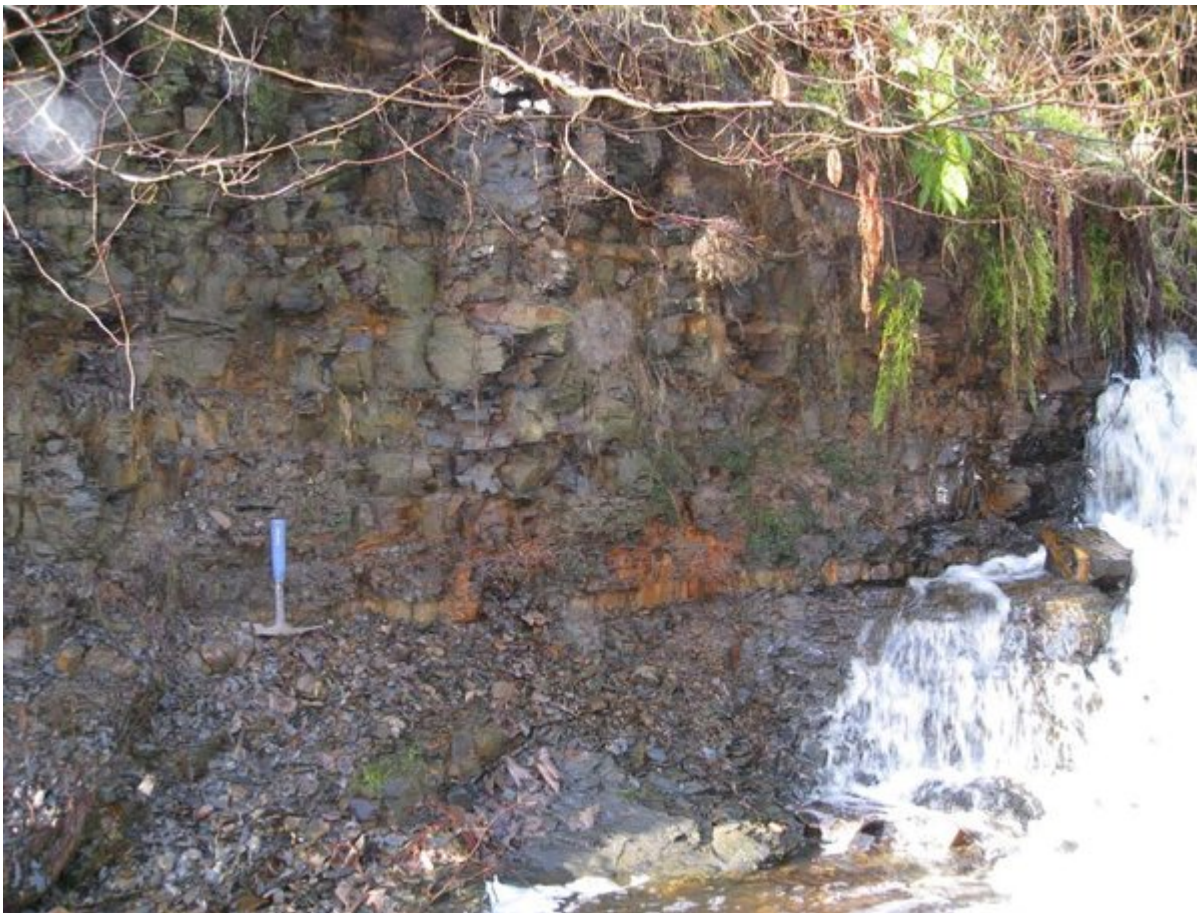
(Photo 59) Section through laminated black mudstones with several rusty-coloured ironstone bands. Looking SW.

*(Photo 59) Section through laminated black mudstones with several rusty-coloured ironstone bands. Looking SW.*

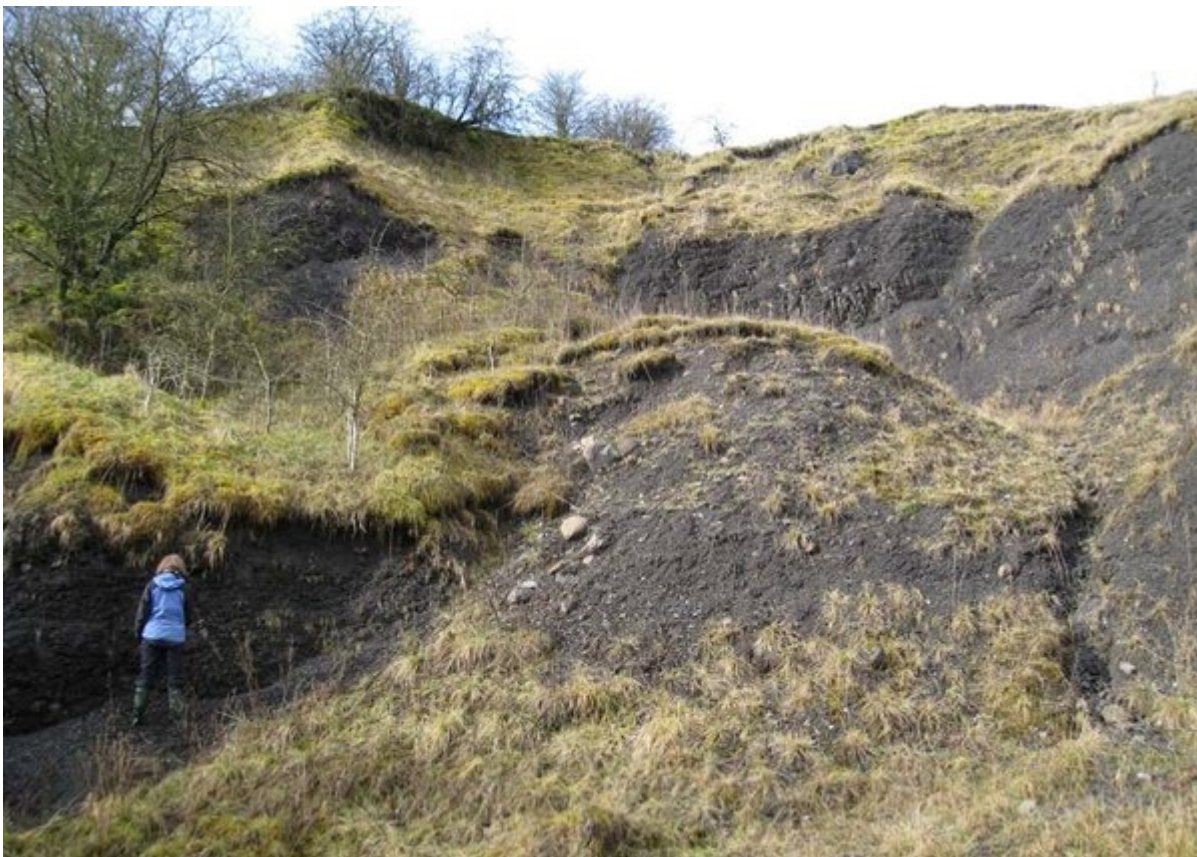
(Photo 60) The main face at the western end of the quarry, comprising a series of degraded sections through black mudstones. Looking SW.

*(Photo 60) The main face at the western end of the quarry, comprising a series of degraded sections through black mudstones. Looking SW.*

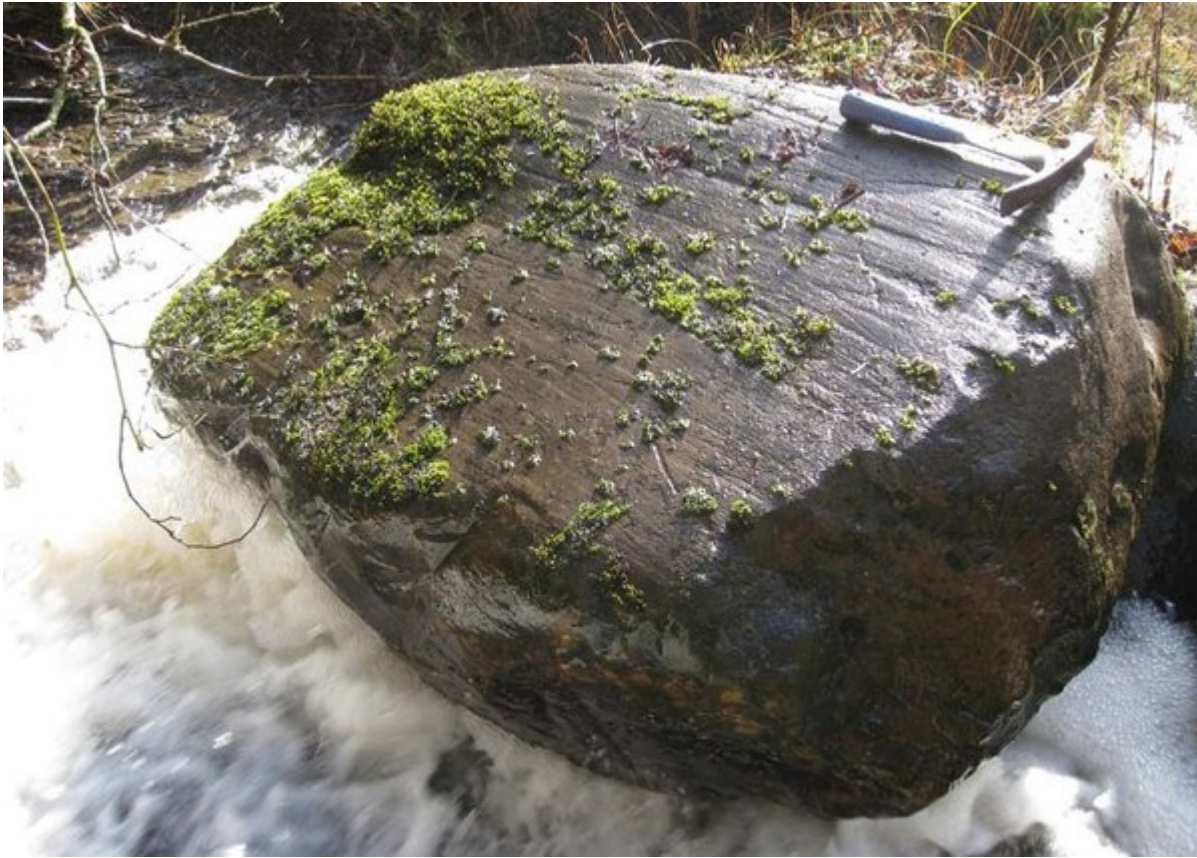
(Photo 61) A superb example of a striated (glacially scratched) boulder, found in the burn entering Barraston quarry from the northwest. It has probably been washed out of a glacial till deposit. Looking SE.

*(Photo 61) A superb example of a striated (glacially scratched) boulder, found in the burn entering Barraston quarry from the northwest. It has probably been washed out of a glacial till deposit. Looking SE.*
