A26 D31 Leys Hill Bridge

Site information

Field surveyor: Scott Engering **Date:** 16/2/07

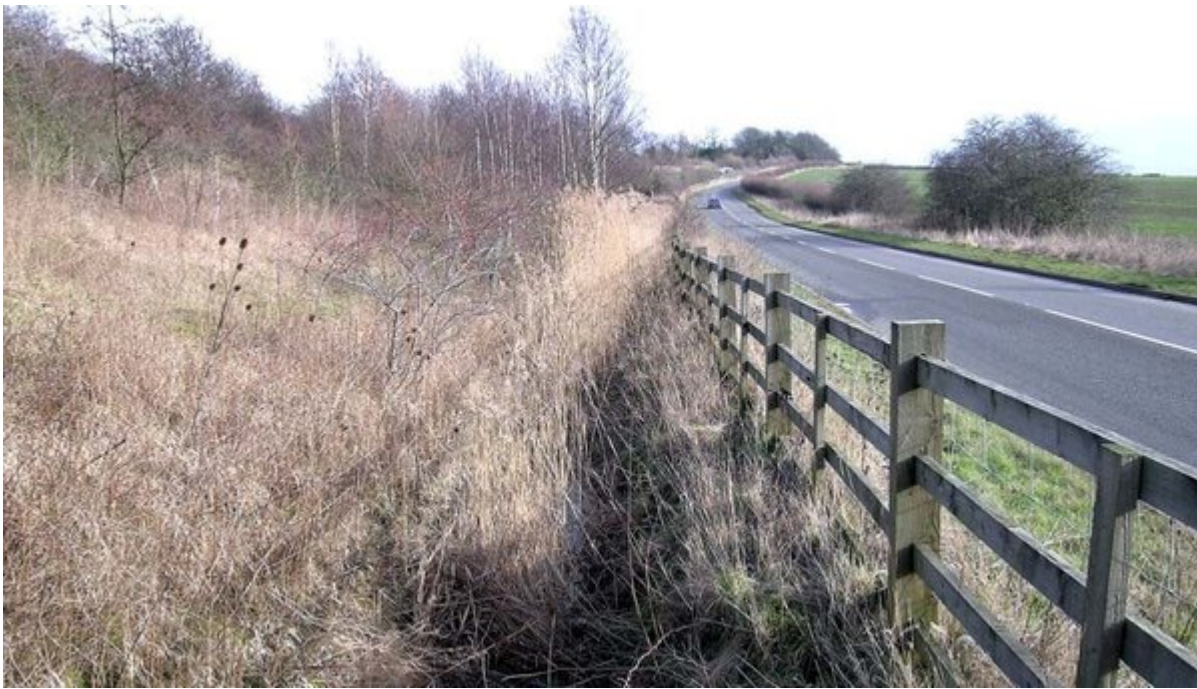
(Figure 123) General view along drainage ditch to the east. [SE 52150 06720].

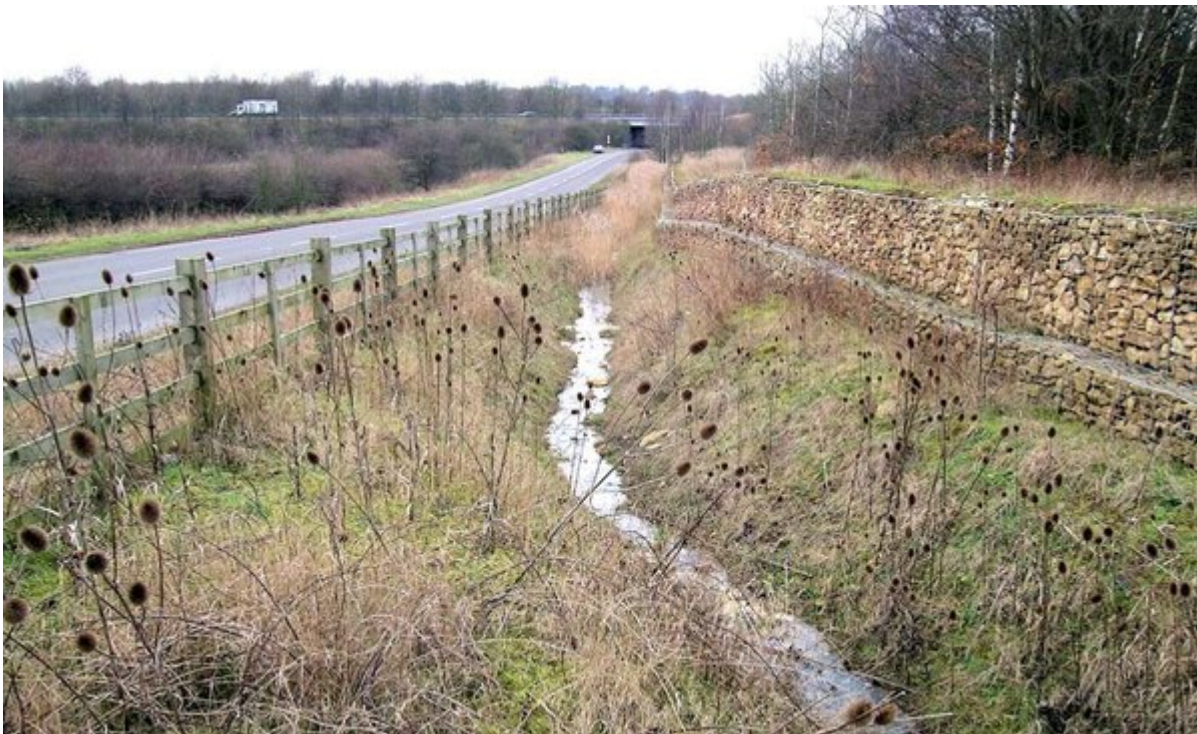
(Figure 124) General view along drainage ditch to the west. [SE 52340 06650].

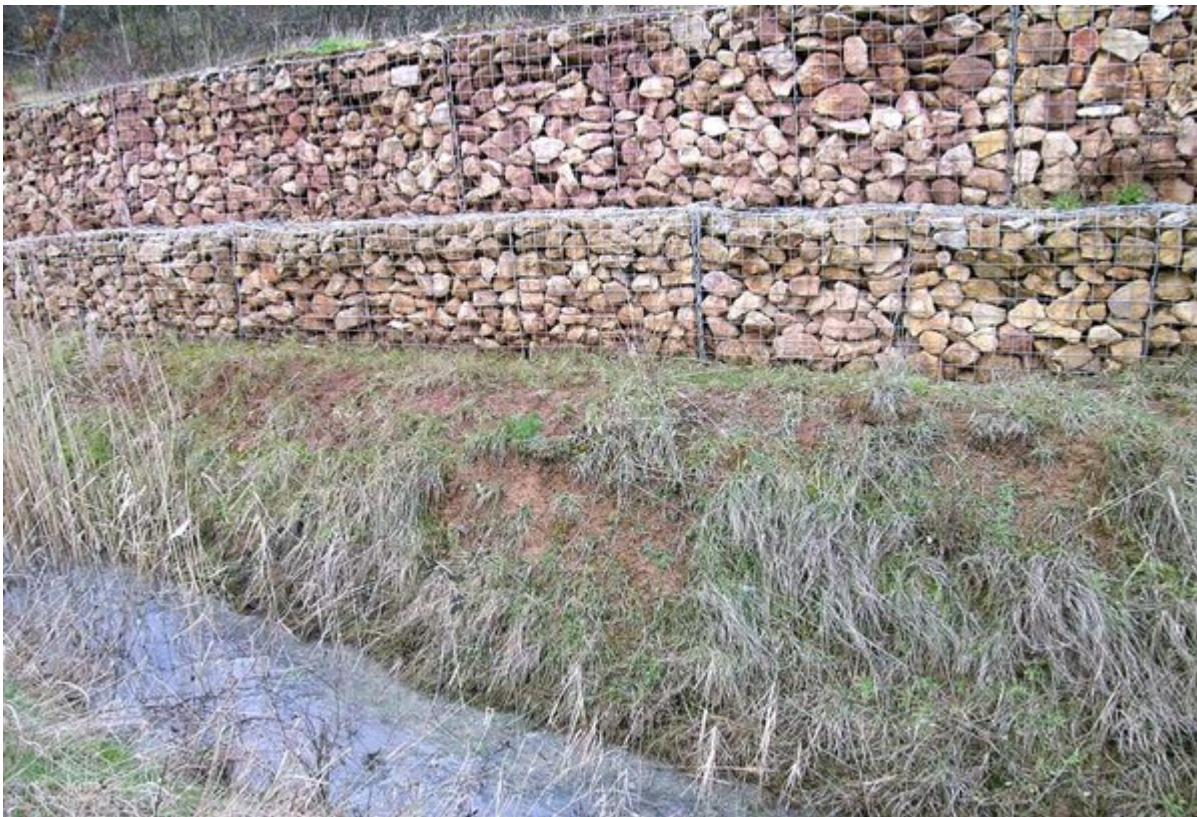
(Figure 125) Exposure of weathered red marl of the Edlington Formation. [SE 52280 06679].

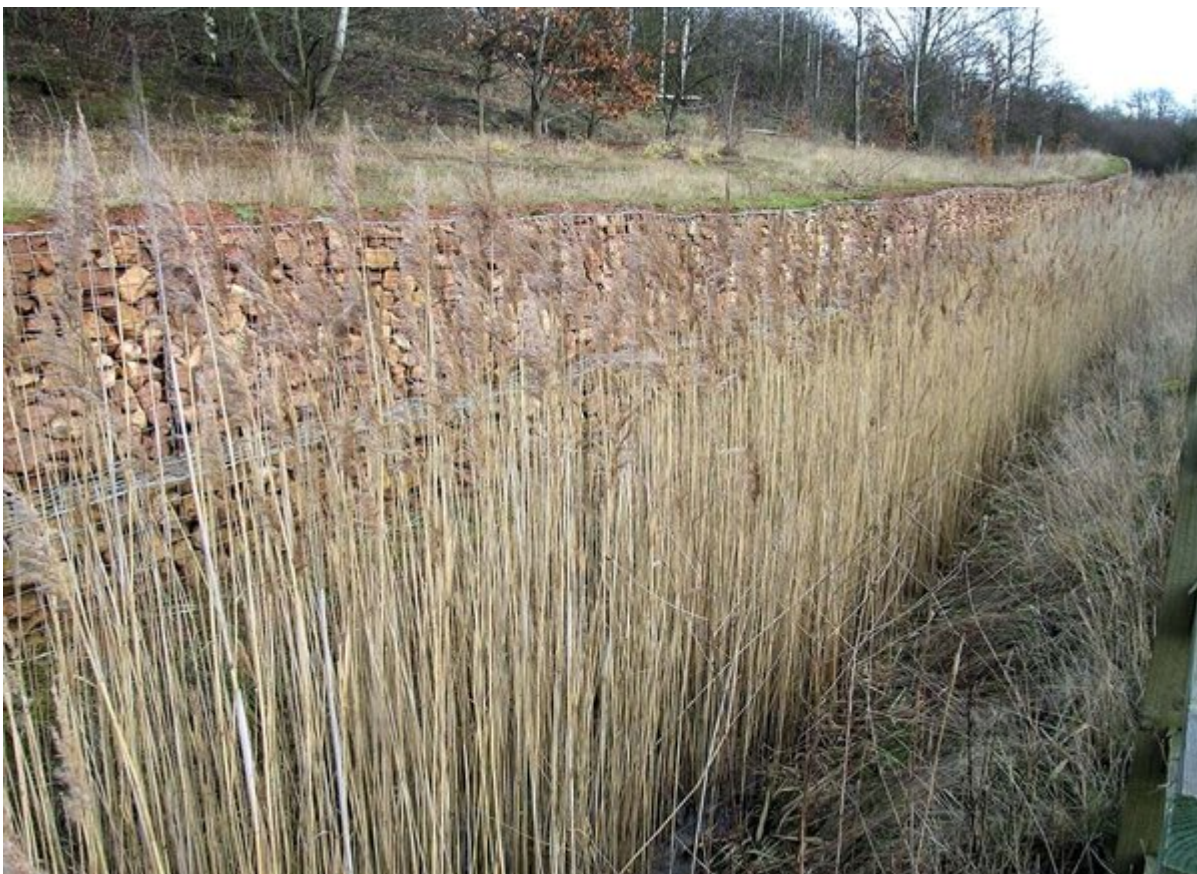
The ditch has been fenced off and planted with hawthorn and gabions have been erected to stabilise the slope. The ditch is now largely overgrown and obscured by osiers with only the occasional exposure of red weathered marl soil now visible. Along the bottom of the ditch and on man made waterfalls, there is a white/grey precipitate but this bears no obvious relationship with the marl exposures.

Current condition Largely overgrown and obscured by grass, hawthorns and osiers D/K

(Figure 126) View of osiers that largely obscure the exposures of marl in the drainage ditch. [SE 52280 06679].
