Spireslack Locality 10: View of major fault

NGR: [275188 630710] [NS 75188 30710]

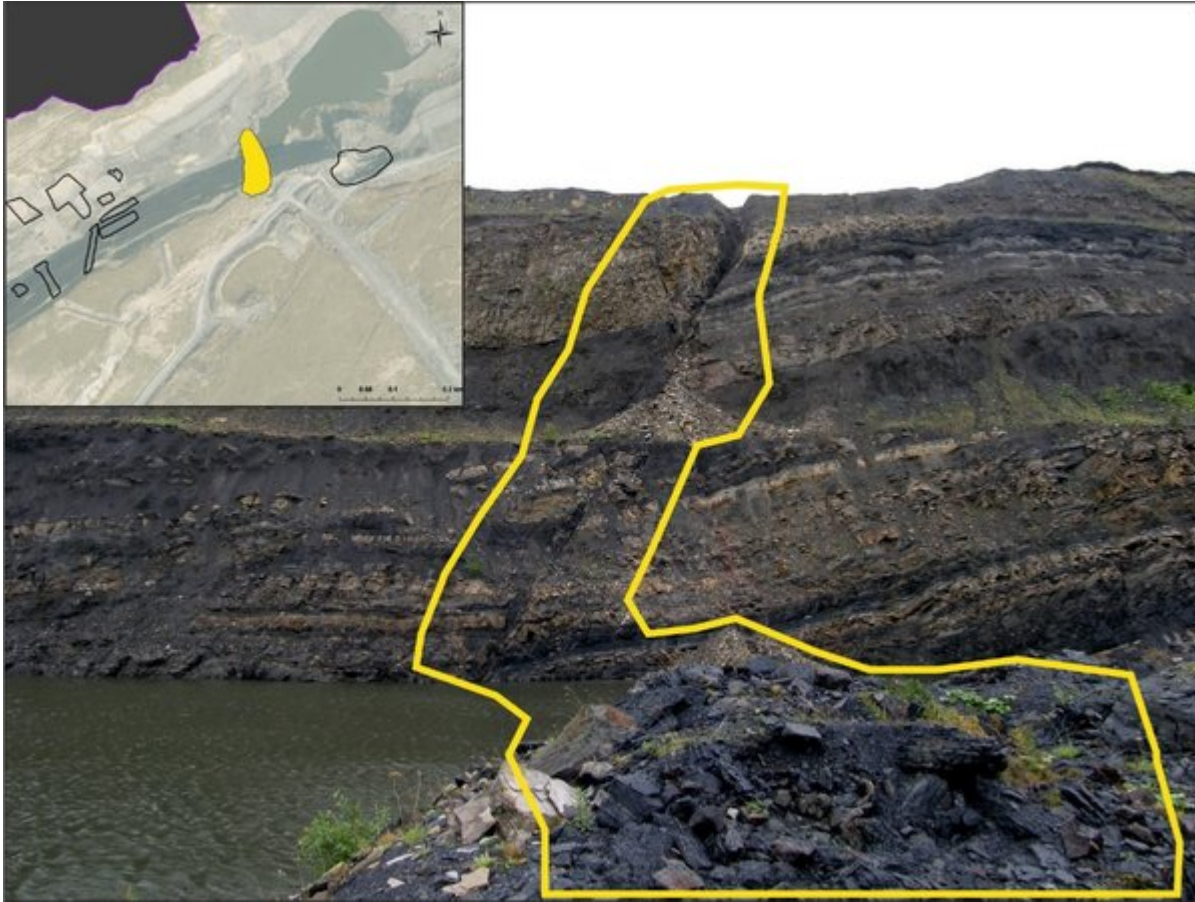
Photograph overview with polygon boundary

Current safety: Viewing area would be safe but there is clear evidence of loose rock falling from higher in the fault zone, forming an active debris cone: therefore close approach to this location is dangerous. Deep pond between potential viewing platform and fault.

(Overview of Locality 10). Site boundary includes key rock exposures, immediate access to site and potential viewpoints to the site (foreground in right of photo overview). Note active debris cone accumulating half way up main scarp. Photo looking to the south.

Measures to enhance site: Flatten out the ground in front of the site as viewing platform.

The fault itself is inaccessible due to the danger of rock fall on the scarp, and also the presence of the deep pond in front of it. This site in any case is better viewed from a distance to appreciate the displacement of the rocks on either side of the fault. Some of the larger spoil piles on the north-west side of the pond could be levelled to provide a viewing platform.

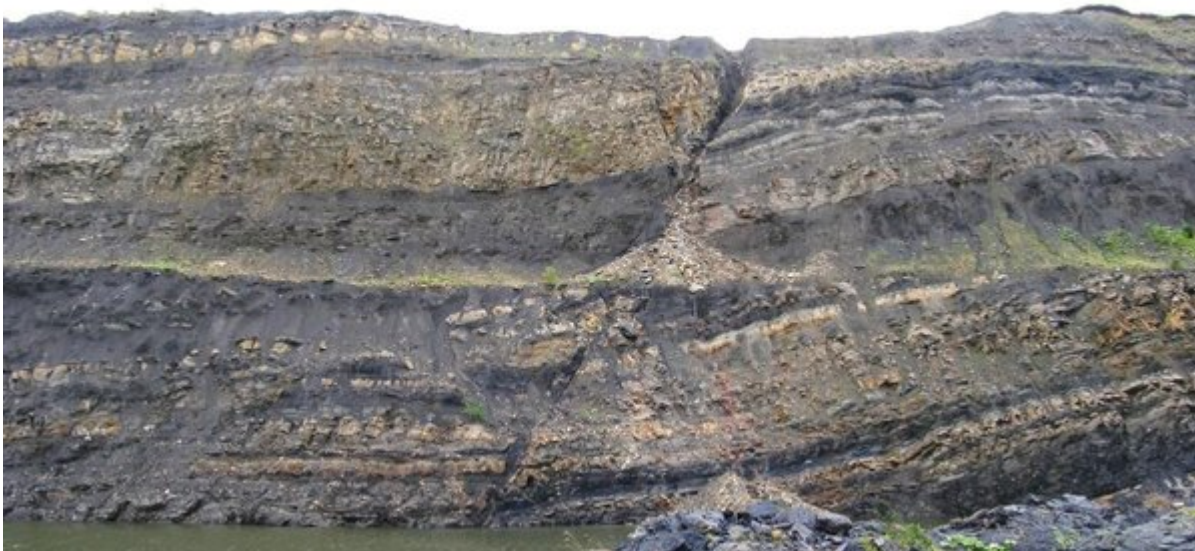
(Spireslack_10 P1): Fault in the south wall, displacing rocks in an apparent normal sense down to the east (left of the image), but also to the north in an oblique sinistral fashion. The weaker fault rocks have been eroded along the fault plane, leaving a cleft marking the position of the fault. Sandstone tends to fracture when faulted — the fractured sandstone has washed out of the fault plane to form a localised debris cone half way up the scarp. Photo facing south. ©

(Spireslack_10 P1) Fault in the south wall, displacing rocks in an apparent normal sense down to the east (left of the image), but also to the north in an oblique sinistral fashion. The weaker fault rocks have been eroded along the fault plane, leaving a cleft marking the position of the fault. Sandstone tends to fracture when faulted — the fractured sandstone has washed out of the fault plane to form a localised debris cone half way up the scarp. Photo facing south. © BGS, NERC.
