Spireslack Locality 11: Section through old mine workings with in-situ pit prop

NGR: [274976 630578]–[274923 630554] [NS 74976 30578]–[NS 74923 30554]

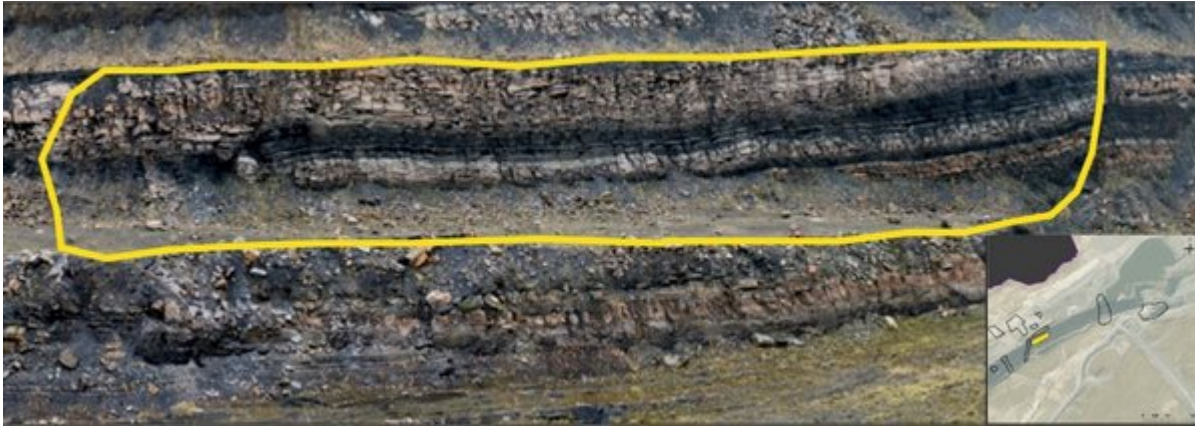
Current safety: Loose material noted spalling off main scarp, potential loose overhanging blocks above section.

(Overview of Locality 11). Site boundary includes key rock exposures, immediate access to site and viewpoints to the site. View looking south onto scarp, at western edge of lower void.

Measures to enhance site: Create dedicated viewing area for platform.

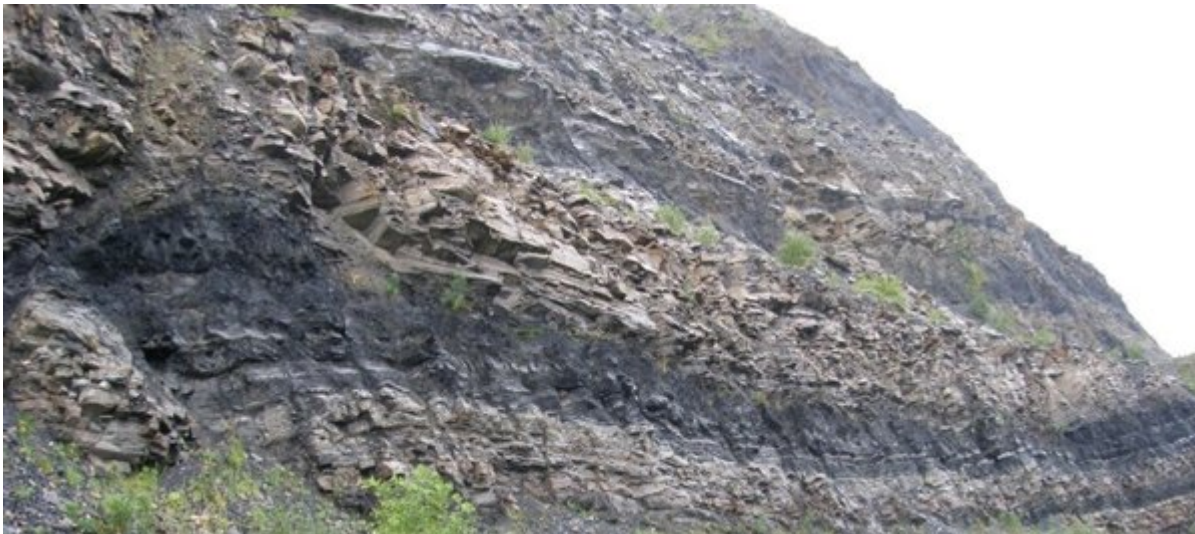
(Spireslack_11 P1): Section with the Limestone Coal Formation in the scarp at Spireslack. The dark band is the Muirkirk Nine Foot Coal. The left hand side of the image shows the original thickness of this seam, before it narrows and is replaced by packed mine waste. Photograph looking south-west toward main scarp. © BGS, NERC.

(Spireslack_11 P1) Section with the Limestone Coal Formation in the scarp at Spireslack. The dark band is the Muirkirk Nine Foot Coal. The left hand side of the image shows the original thickness of this seam, before it narrows and is replaced by packed mine waste. Photograph looking south-west toward main scarp. © BGS, NERC.

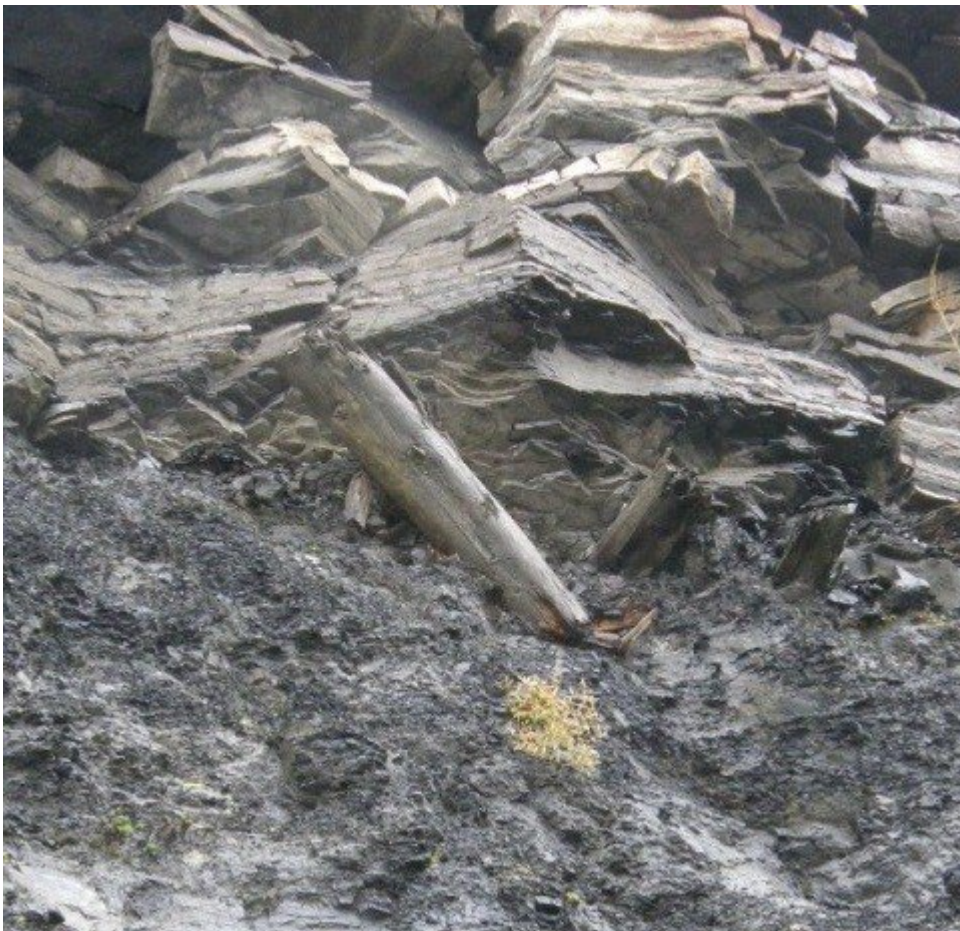
(Spireslack_11 P2): Wooden pit prop in situ within the coal workings. The wooden props were used to hold up the roof of the workings as the coal was extracted. The prop, sitting above packed mine waste in the photo, has since collapsed due to the overlying weight of rock (sandstone) above. © BGS, NERC.

(Spireslack_11 P2) Wooden pit prop in situ within the coal workings. The wooden props were used to hold up the roof of the workings as the coal was extracted. The prop, sitting above packed mine waste in the photo, has since collapsed due to the overlying weight of rock (sandstone) above. © BGS, NERC.
