ELC_17: Esk Valley

Site information

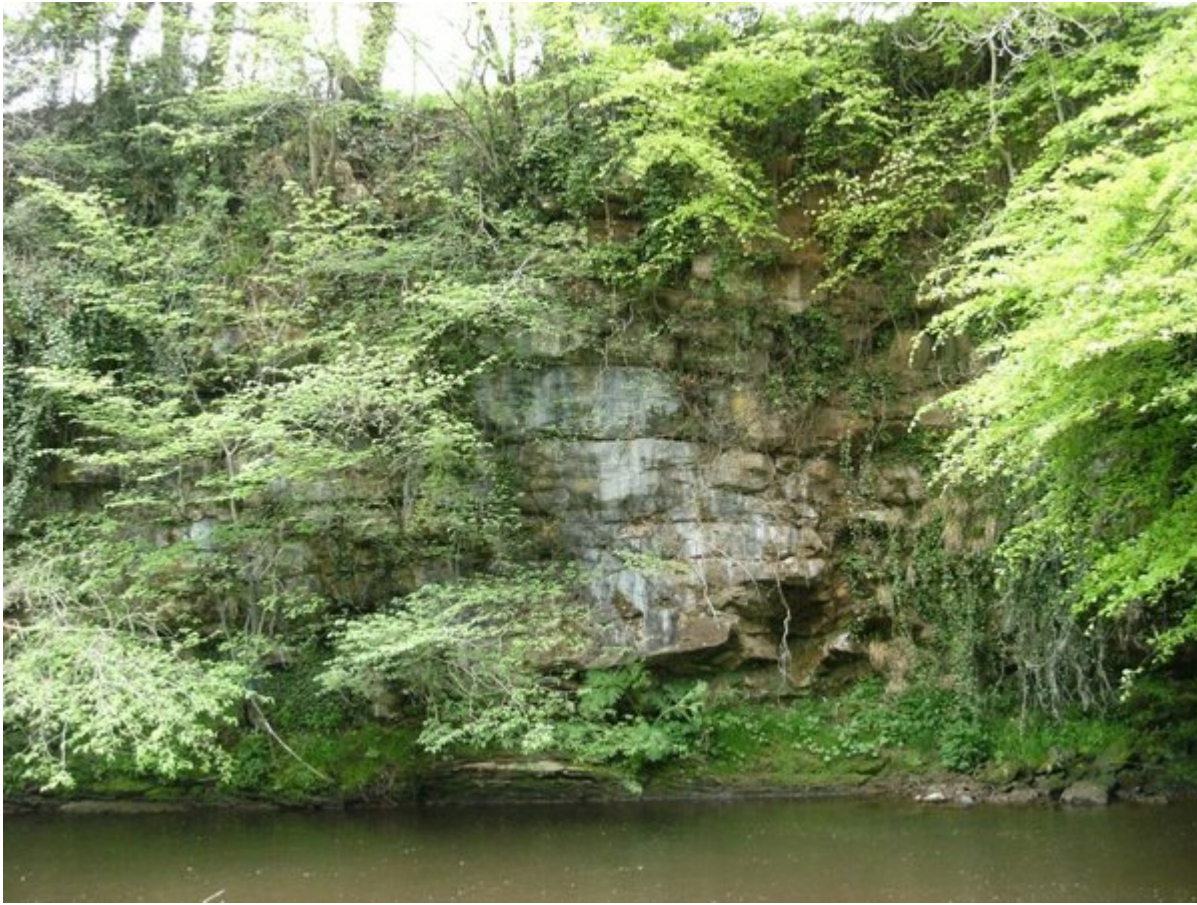
The Middle Coal Measures Formation is a cyclic sequence of white, grey and brown sandstone and siltstone with dark grey mudstone and coals and seatearths. The sandstone and softer siltstone and mudstone are exposed in cliff sections along the west bank of the River Esk (ELC_17_P1). The sandstone is locally channelized (erosional base; (ELC_17_P2),

(ELC_17_P1) Cliff section on the west bank of the River Esk. The buff coloured sandstone can be seen resting on the softer mudstone/siltstone which is undercuts the sandstone. © BGS, NERC.

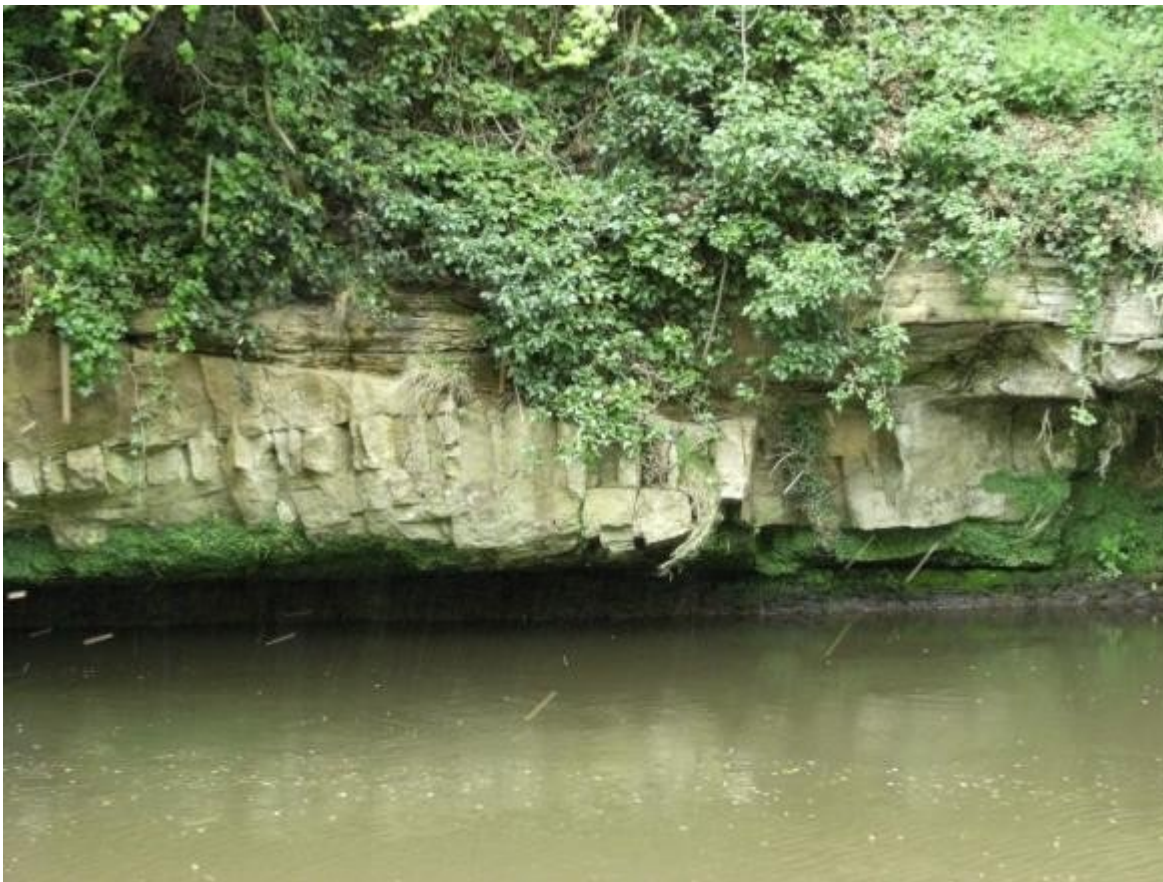
and the contact between the sandstone and underlying mudstone/siltstone is a sharp and erosive indicating high energy deposition in streams. In channel sandstones exposed on the east bank of the River Esk a layer of large carbonised wood and plant fragments can be seen at the base of the unit indicating that during flood flows, the channels carried woody debris and deposited it within the channel sediments (ELC_17_P5). Below the sandstone is a coal layer approximately 20cm thick (ELC_17_P6).

(ELC_17_P2) The thinly bedded sandstone slightly obscured by vegetation appears to be a channel which has cut into the thicker bedded sandstone below. The sharp, erosive contact between the sandstone and the undercutting mudstone/siltstone can be clearly seen © BGS, NERC.

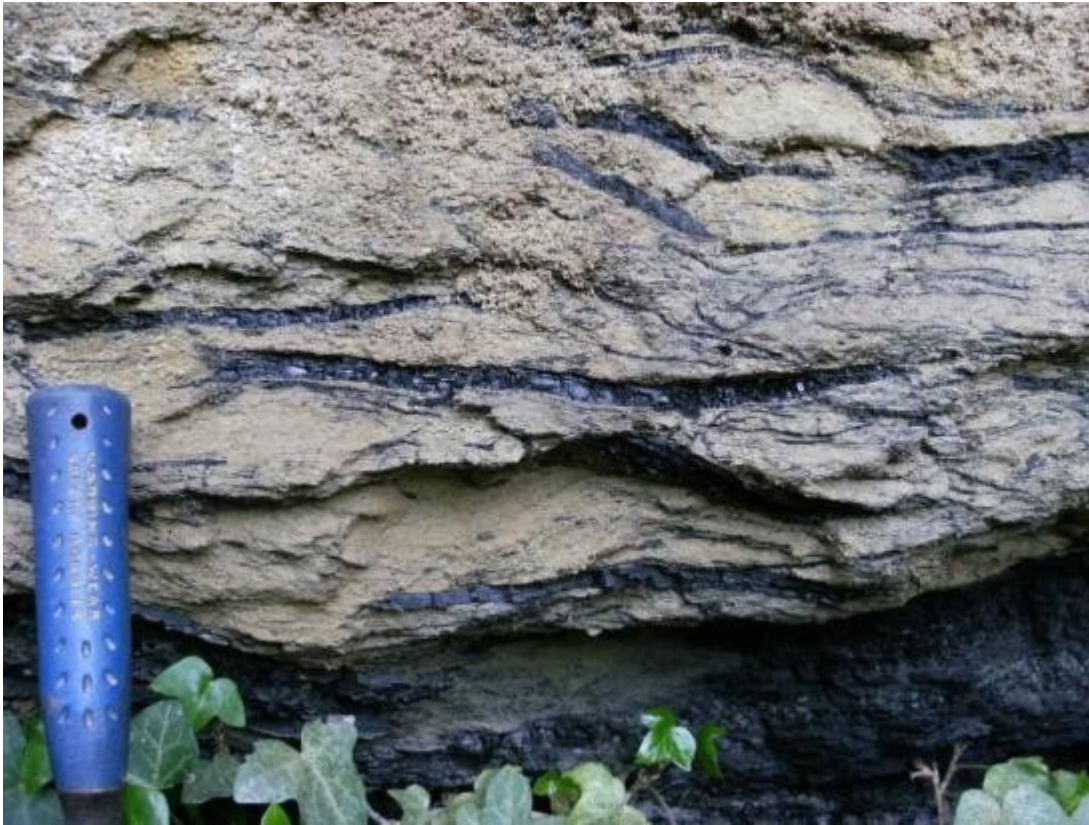
(ELC_17_P5) Coal rafts seen in consolidated material at the base of the sandstone. The coal deposits may have been transported by the sand during deposition in a fluvial environment or are plants remains which have been carbonised into coal. © BGS, NERC.

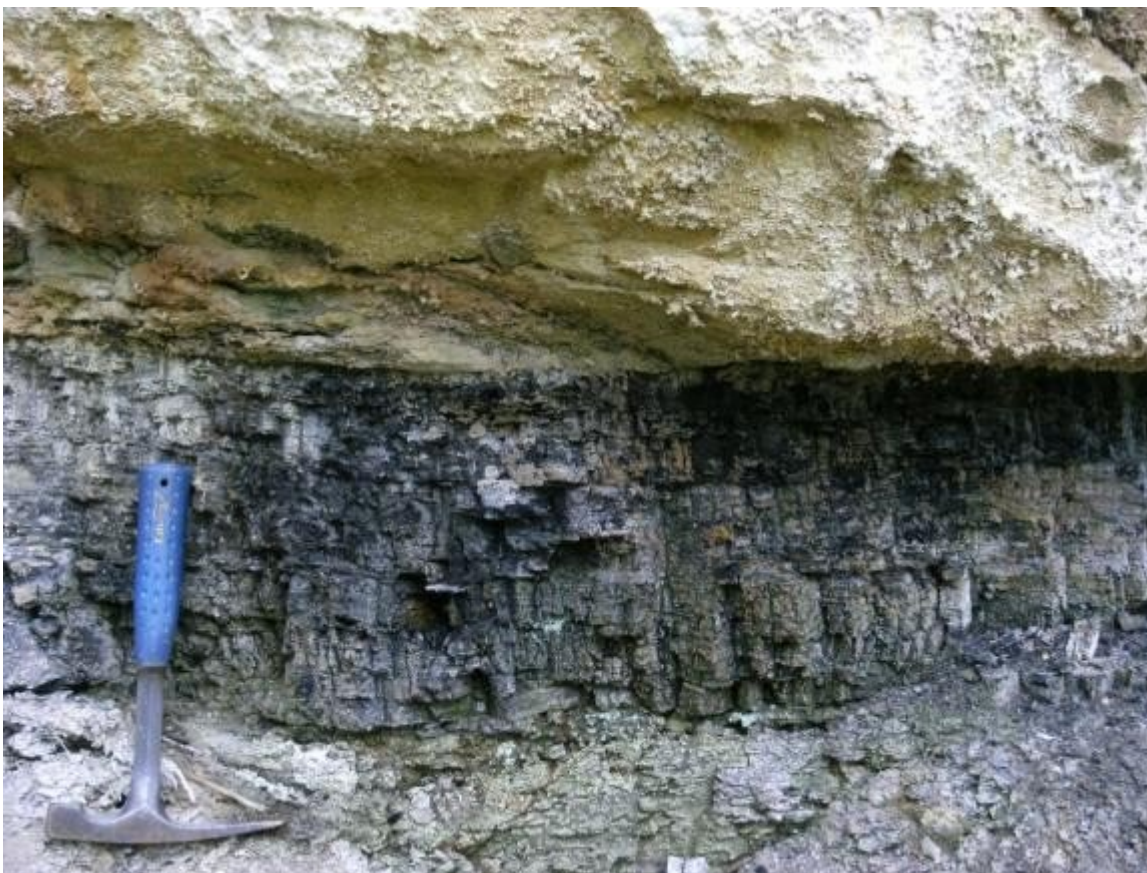
(ELC_17_P6) 20cm layer of coal at the base of the sandstone. The coal is dull black, fractured and sulphurous, yellow staining can be seen. © BGS, NERC.

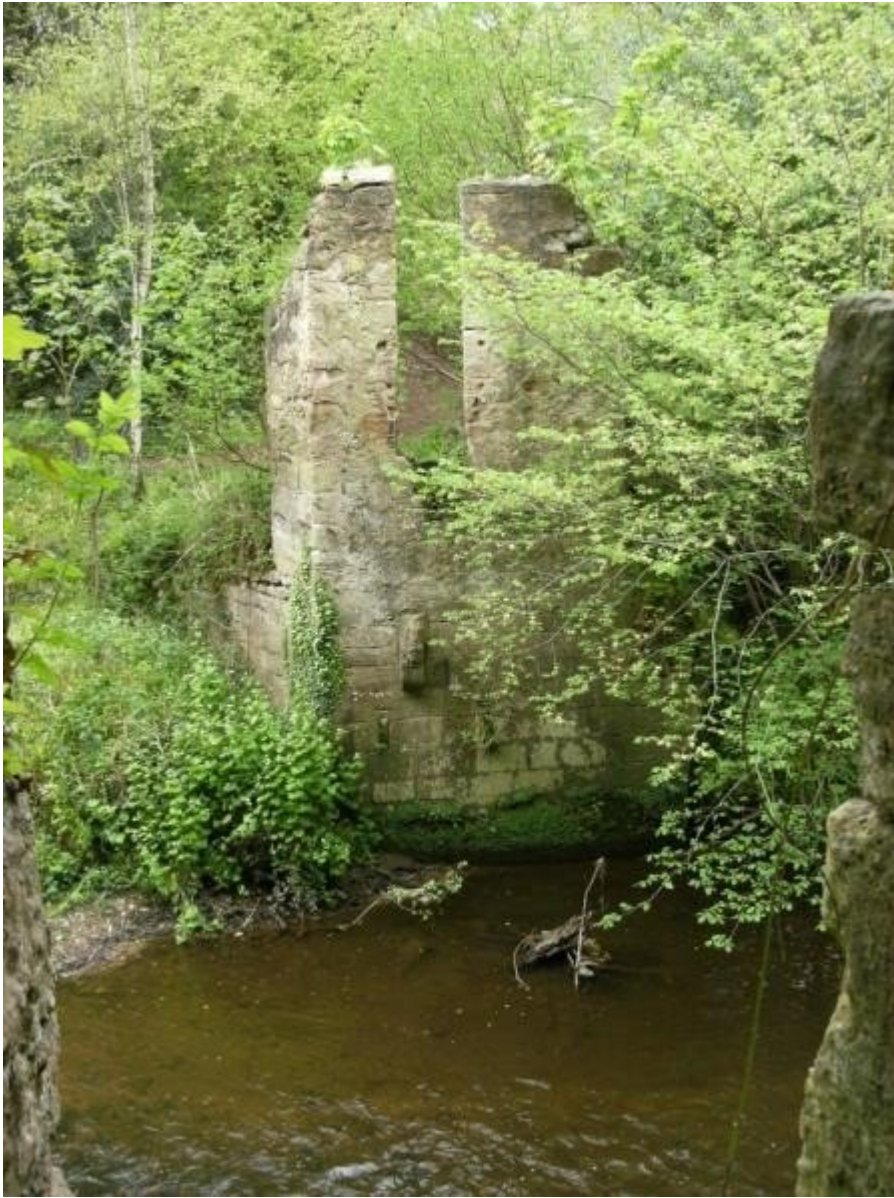
Access to the River Esk at this locality can be made by parking within the village of Smeaton and crossing the A6094 at Smeaton Lodge. The road can then be followed down to Smeaton Bridge. Even though this is a private estate the area appears used by local dog walkers. A bridle path runs from Smeaton Bridge on the east side of the river to Pickle Dirt on the south side of the A68. The path is a pleasant walk giving access to exposures on the east bank of the River Esk and views to the exposures on the west bank of the River Esk. Two footbridges are marked on the 1:10 000 OS map but neither of these still cross the river, (ELC_17_P9), therefore not giving access to the west bank of the river or offering a circular route.

(ELC_17_P9) The footbridge at the 'Meeting of the Waters' is no longer in use. © BGS, NERC.

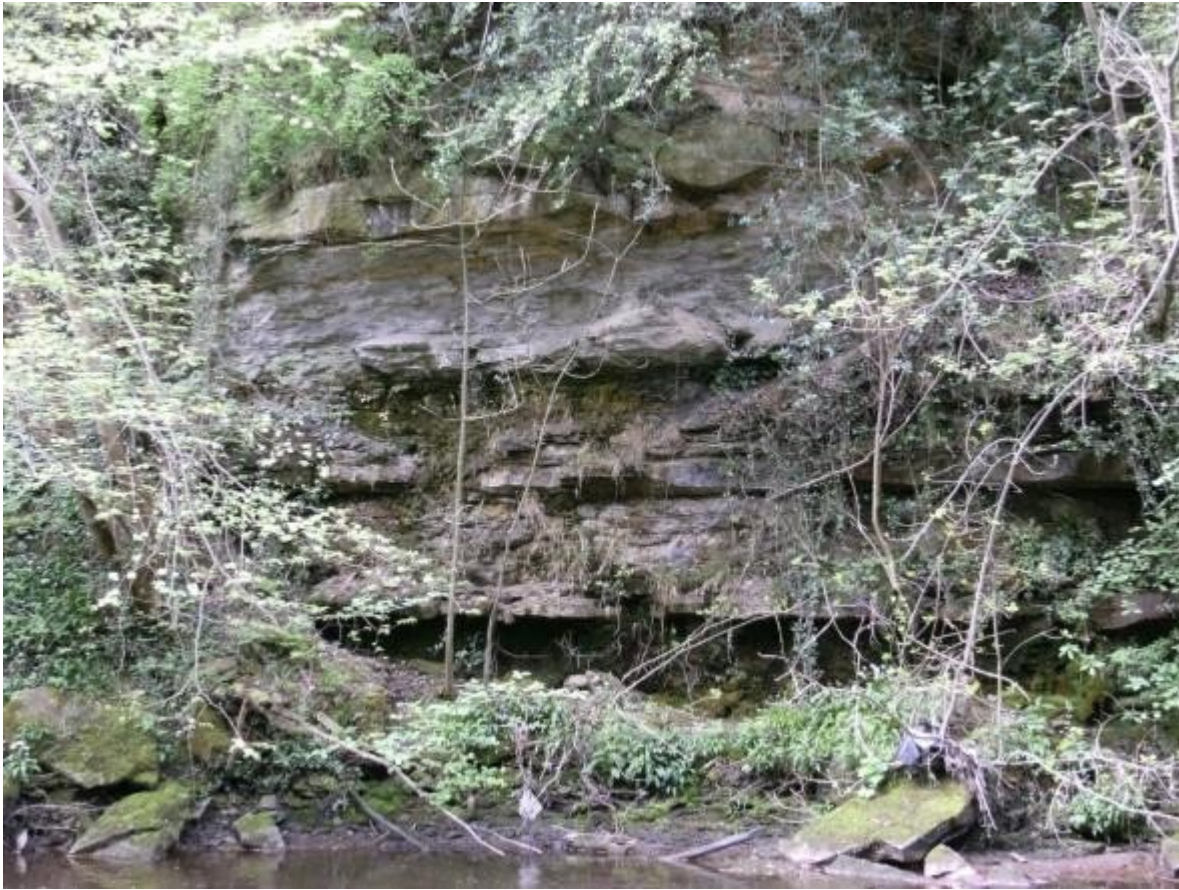
(ELC_17_P3) Interbedded sandstone showing differing lithologies, the finer grained silty sandstone beds are being eroded more quickly giving rise to prominent beds of sandstone. © BGS, NERC.

(ELC_17_P3) Interbedded sandston showing differing lithologies, the finer grained silty sandstone beds are being eroded more quickly giving rise to prominent beds of sandstone. © BGS, NERC.

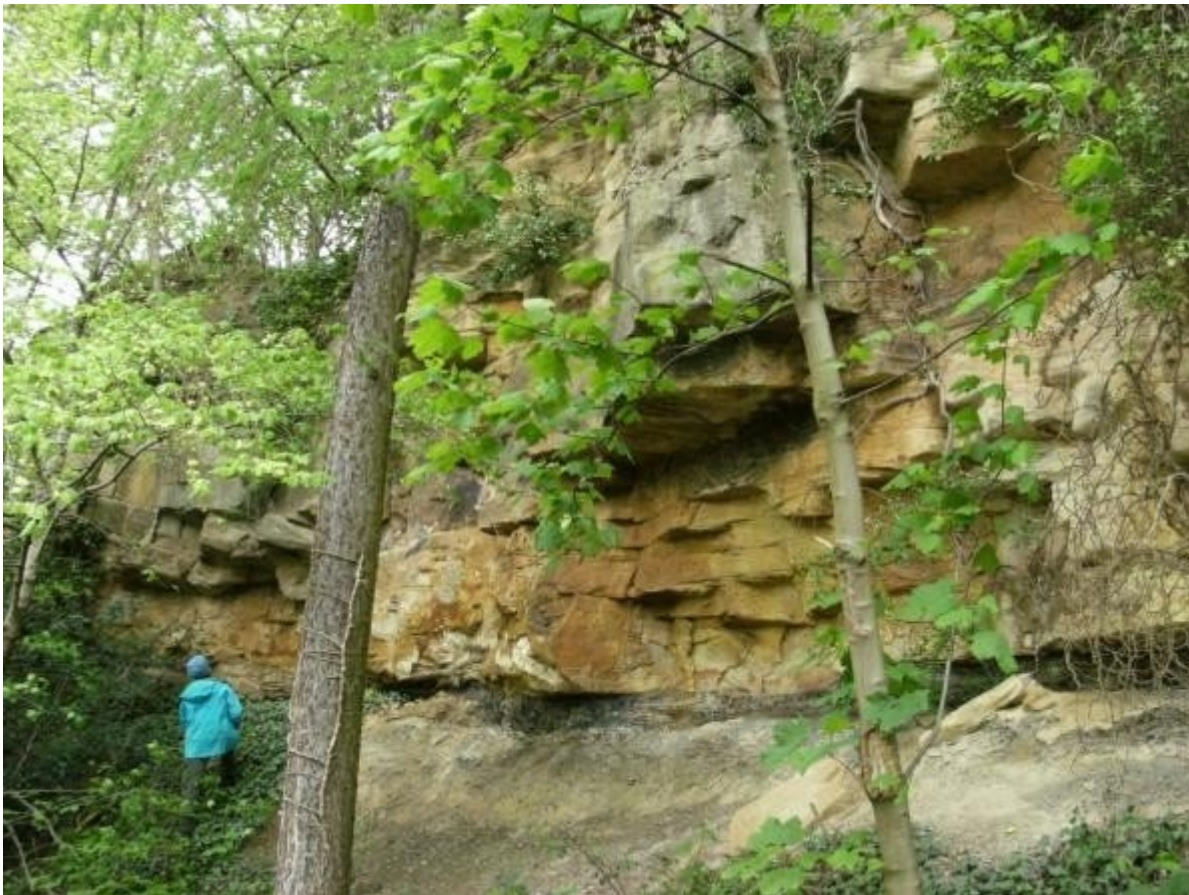
(ELC_17_P4) Cliff section on the east bank of the River Esk. Exposure is showing massive bedded yellow/orange sandstone with a thin layer of coal exposed at its base. Erosive debris at the base of the section is obscuring the true thickness of the coal. © BGS, NERC.

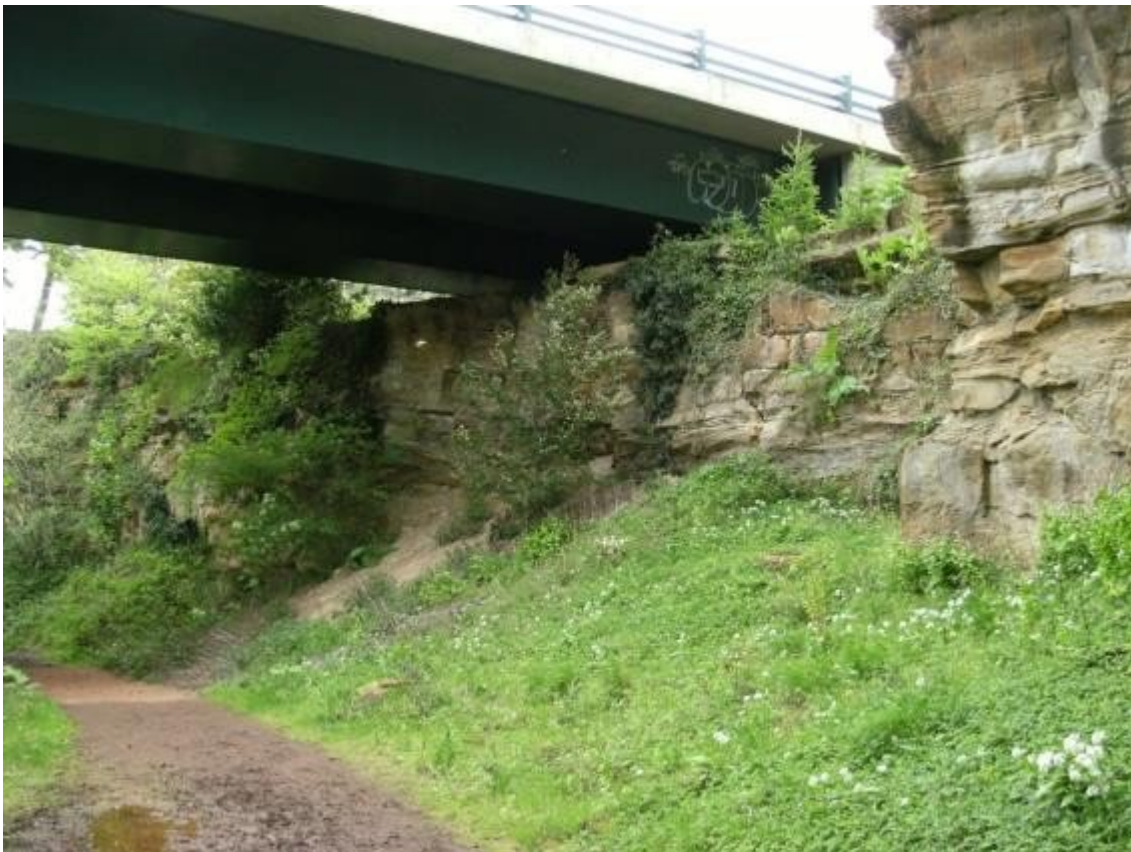
(ELC_17_P7) Cliff section continues along the east bank of the River Esk and has been used as a foundation for the A68 which crosses the river at this point. © BGS, NERC.

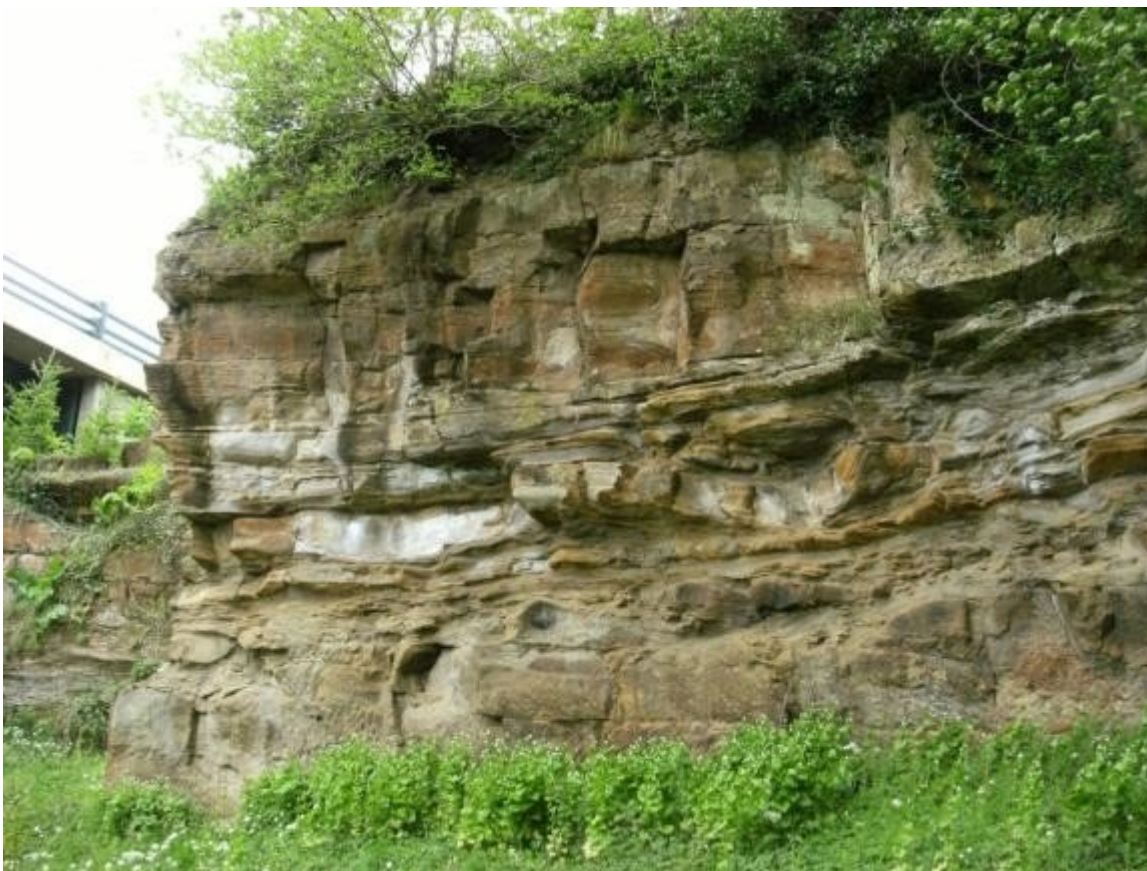
(ELC_17_P8) Cliff section exposing thick beds of sandstone interbedded with thinner beds of silty sandstone. Due to their lithology they are eroding more quickly than the thicker micaceous sandstone beds. The base of the thinner beds indicates a channel like structure. The coal exposed just north of this section is not seen at this location. © BGS, NERC.
