# A15 D112 Parknook Quarry

## Site information

**Site name:** Parknook Quarry

**Site key:** D112

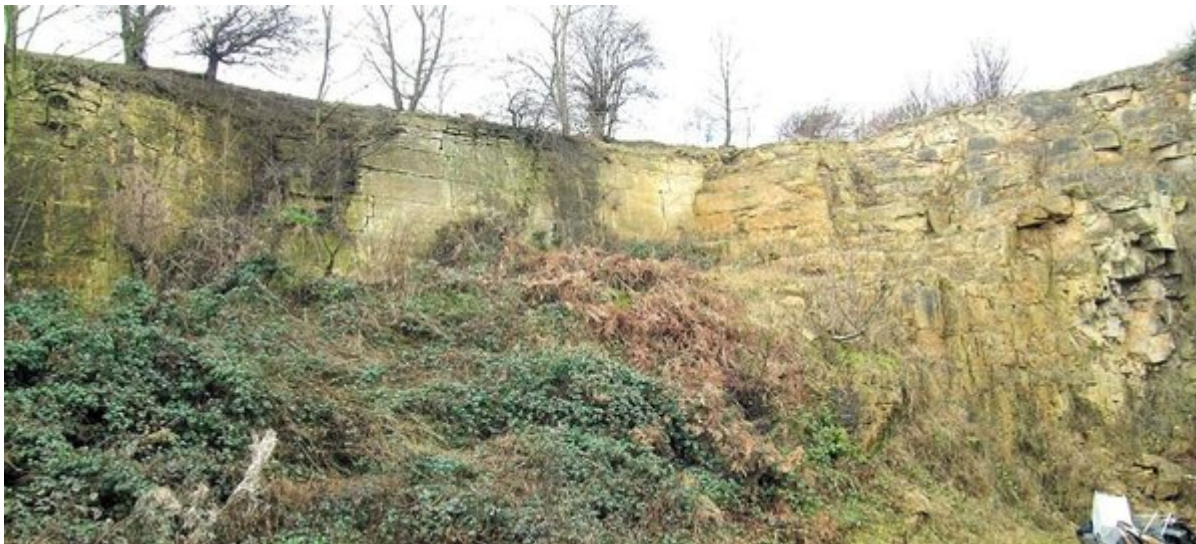
The north-west corner is not accessible but comprises similar lithologies to the above. Here, there are quarry benches and it appears that the building stone was last quarried from here, although the quarry does not appear to have been operational for several years. A recent enquiry by York Minster to the Highways Agency has been made but the outcome

(Figure 79) General view of bedded limestone and former quarry benches to the north-west corner. [SE 51400 12835].

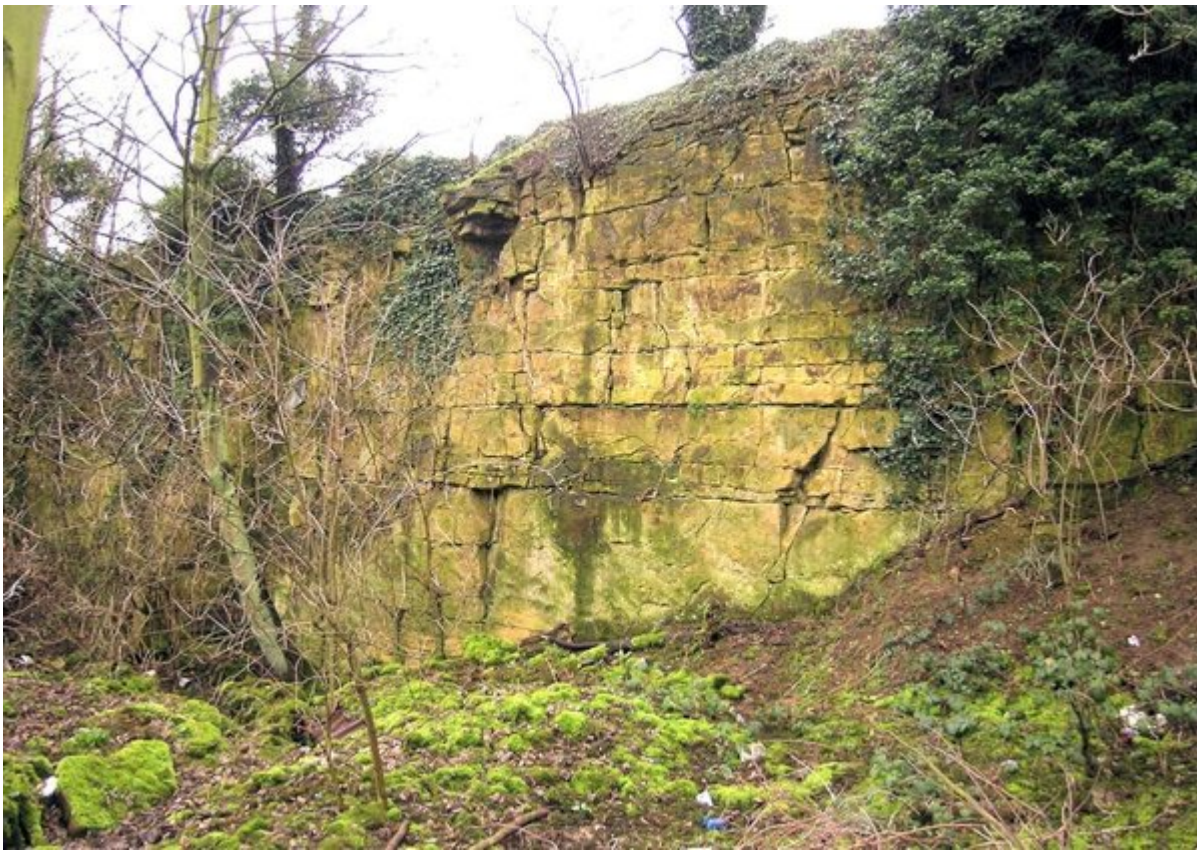
To the west, 6 m of massive limestone similar to the above is exposed. The rock is well weathered and the jointing and internal fracture pattern associated with this rock formation are well displayed [SE 51487 12659]. Stylolites are also visible.

(Figure 80) Horizontal bedded limestones showing typical fracture patterns in the west quarry face. [SE 51487 12659].

*(Figure 80) Horizontal bedded limestones showing typical fracture patterns in the west quarry face. [SE 51487 12659].*

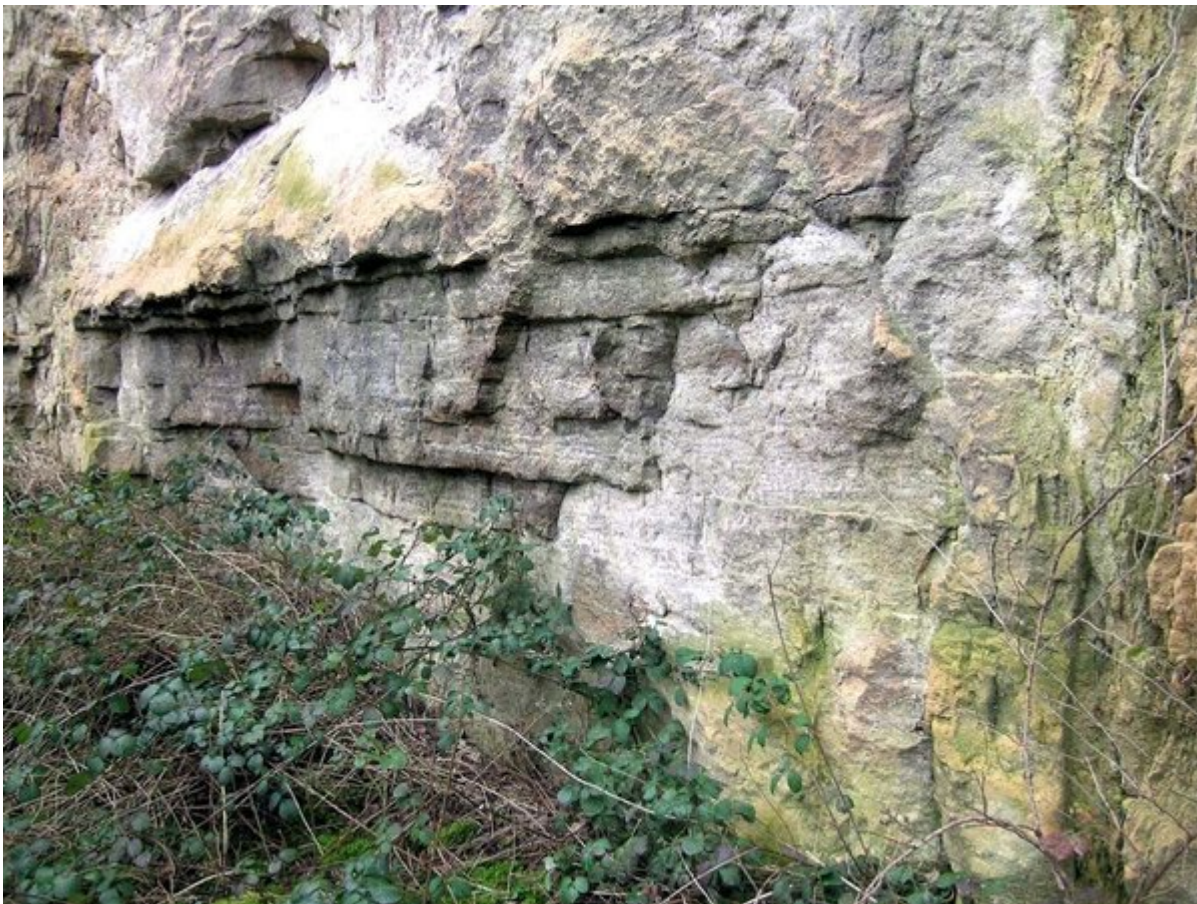
(Figure 81) Well bedded limestone exposed in the lower section of the north quarry face within the Wetherby member. [SE 51440 12850].

*(Figure 81) Well bedded limestone exposed in the lower section of the north quarry face within the Wetherby member. [SE 51440 12850].*
