A19 D78 Warmsworth Park

Site information

Site description

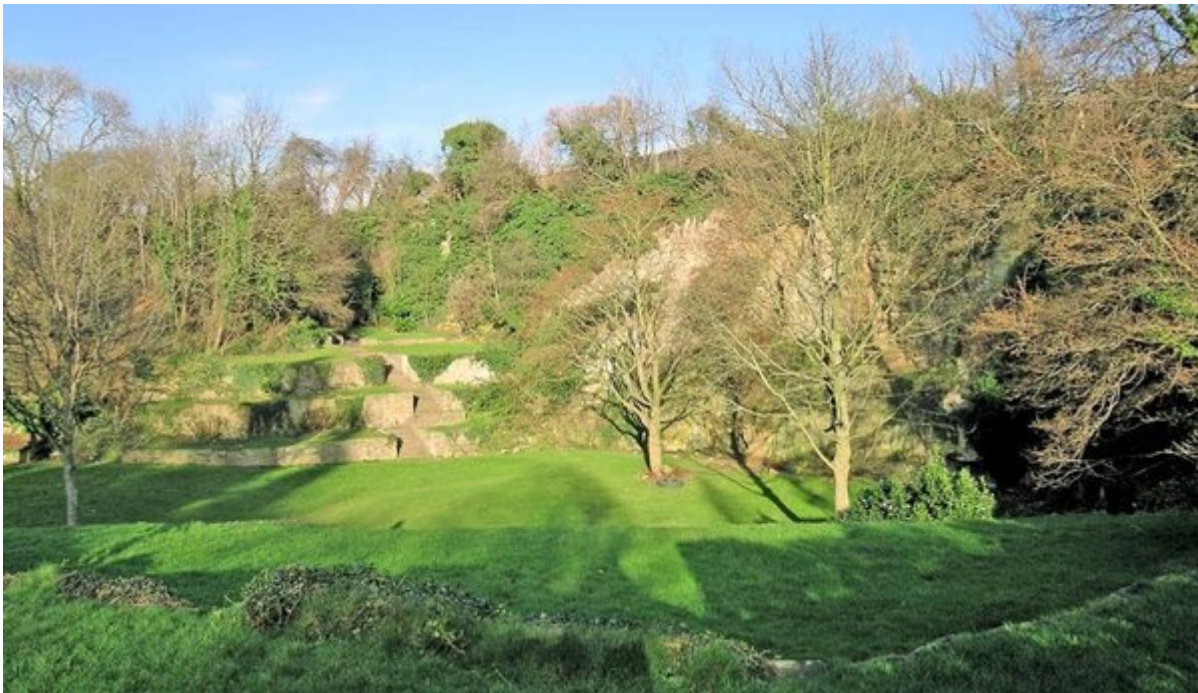
(Figure 96) General view of landscaping of the old quarry benches looking to the north. [SE 54460 00300].

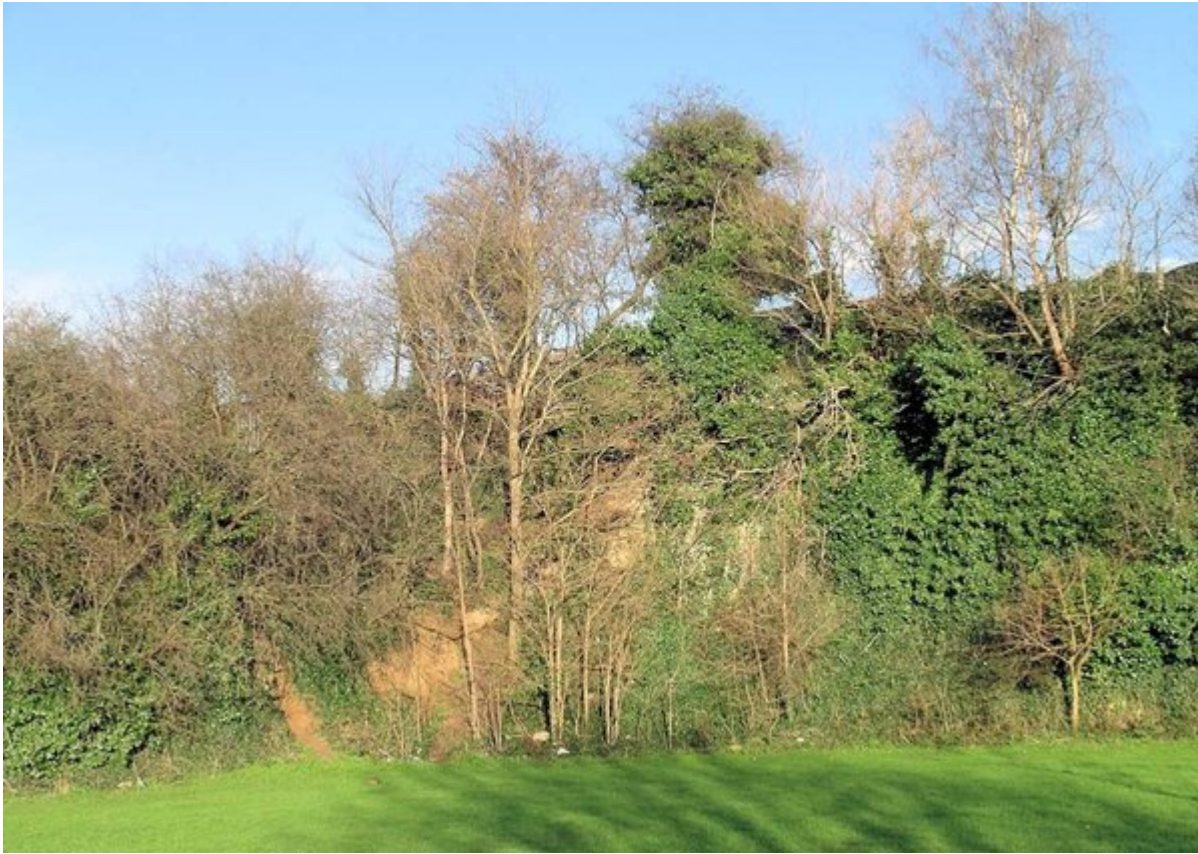
At one location on the eastern side of the quarry, there is a mass of poorly consolidated red/brown sandy material up to 6.5 m thick with angular and sub-rounded fragments which is probably till similar to that seen at Hexthorpe Flatts, Cedar Road Quarry and New Edlington Brick Pit. However, here it occurs at the same level as an 8 m high limestone quarry face. Junctions with the limestone are not exposed and it is not clear if this is a natural deposit in a fault bound rift within the limestone or relates to the former quarrying activities.

(Figure 97) General view of till (left) and limestones of the Sprotbrough Member (right). [SE 54470 00305].

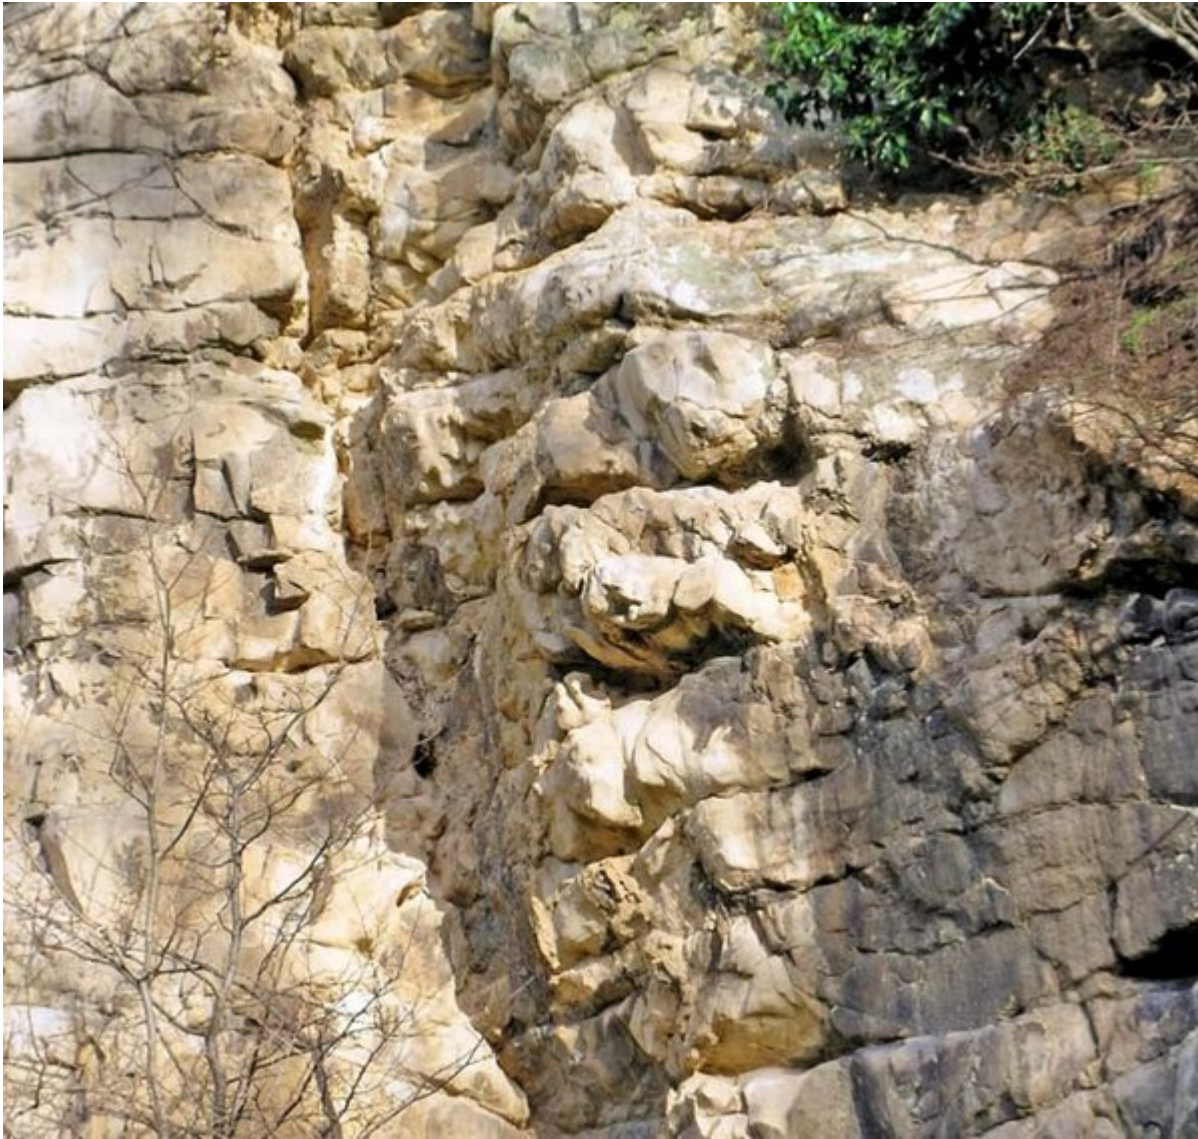
One particularly interesting feature is a vertical joint in a quarry face that shows widening and solution of the limestone by percolating groundwater and is possibly associated with the formation of Karst topography on a once exposed and weathered surface.

(Figure 98) Development of a sink hole and solution features along a joint in the eastern face of the quarry. [SE 54470 00370].
