## EDC 9: Craigdhu Burn, Bearsden

**Site type:** Natural exposure

**Date visited:** 6th March 2009

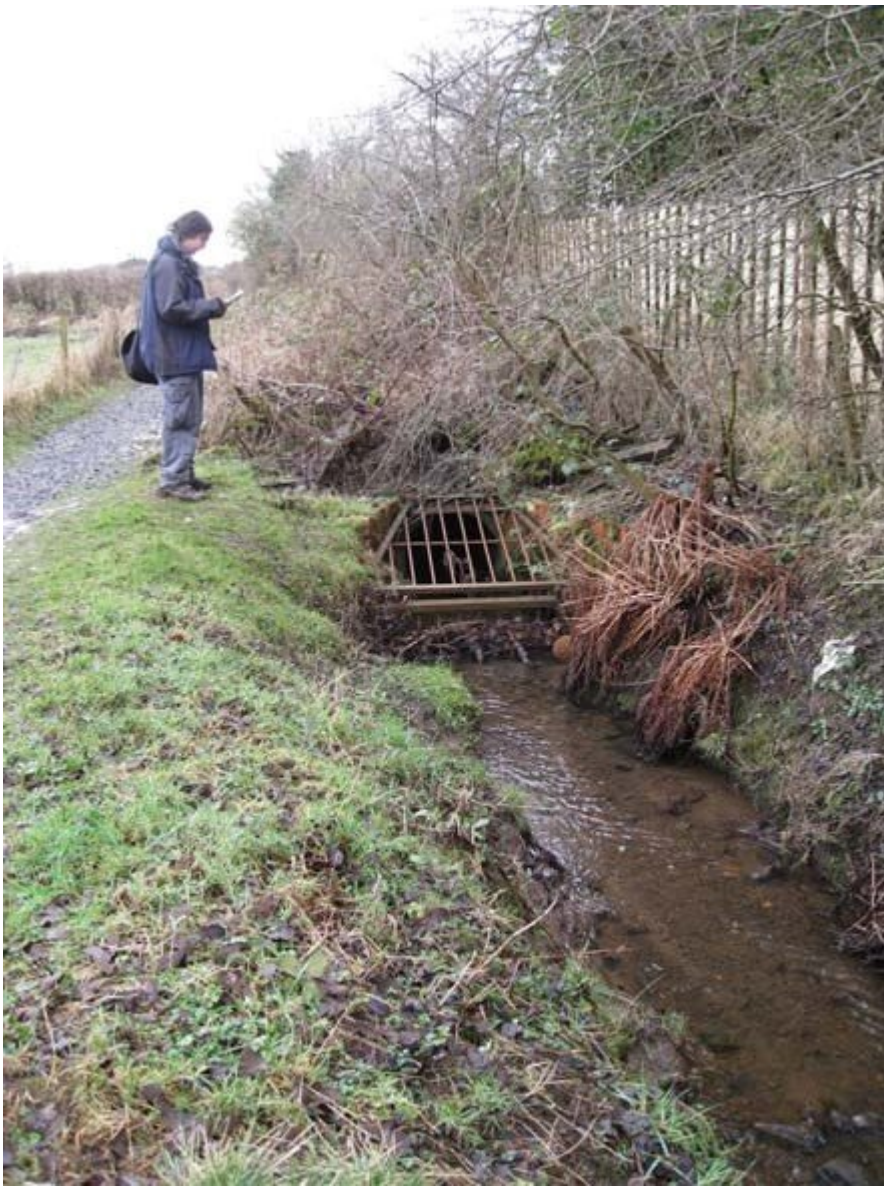
**Current condition** No geology sections exist anymore – burn is now piped underground

**Restricting conditions** Concrete pipe and soil

*(Photo 37) Craigdhu Burn channelled underground. Looking SE.*

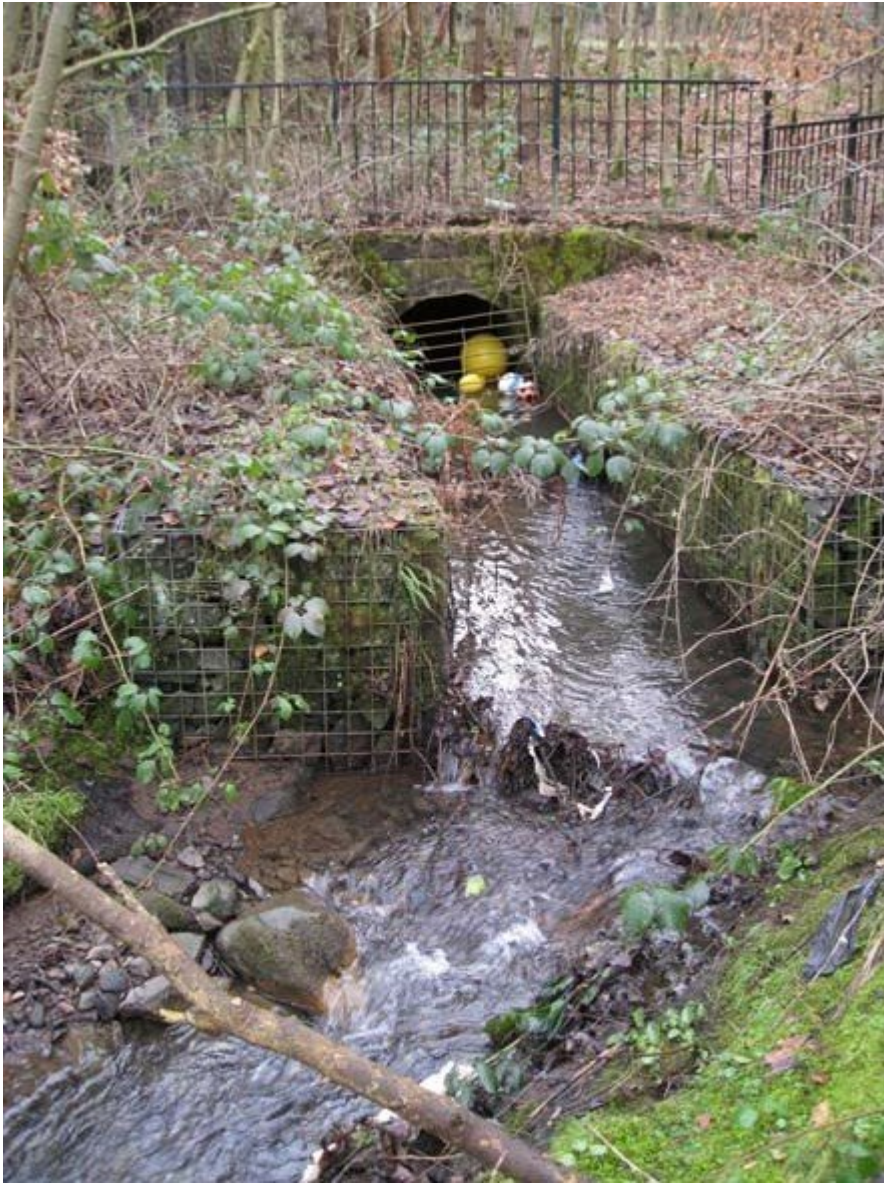
*(Photo 38) Craigdhu Burn re-emerging. Looking WSW.*

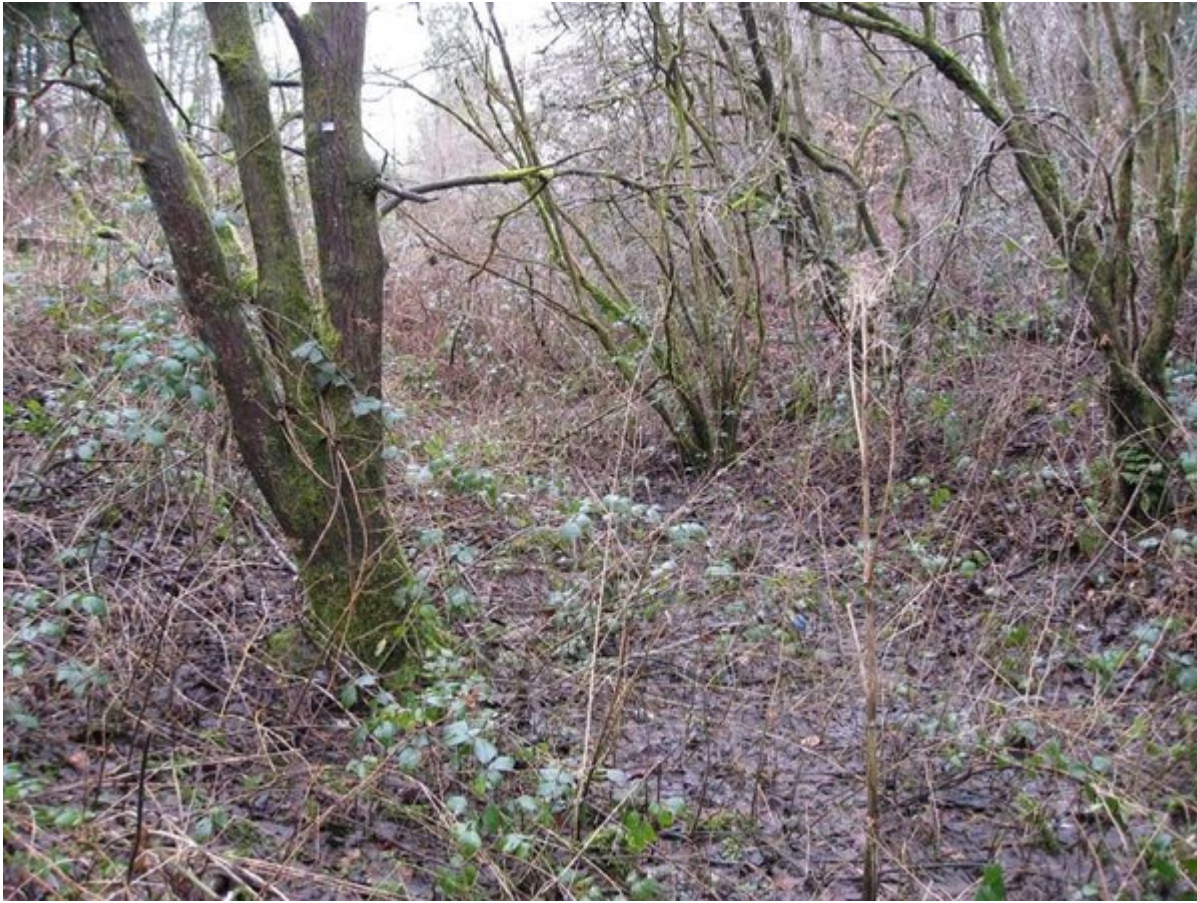
Geological exposures along a tributary of the Craigdhu Burn no longer exist. The burn is now piped underground and exposures have been covered.

The geological map records exposures through the sedimentary strata of the Limestone Coal Formation which contained fossils of the brachiopod 'Lingula' (a marine shell). But no exposures of bedrock are now visible. Where the burn is flowing on the surface to E and W of the recorded exposures, it cuts through glacial till, no bedrock was found.

*(Photo 39) View W along the course of Craigdhu Burn which is now piped underground. Previous geological maps have recorded exposures of sedimentary rocks belonging to the Limestone Coal Formation containing 'Lingula' shell fossils, but these have now been landscaped and lost.*
