# Liuibeg Burn, Aberdeenshire

L.J.McEwen

## Highlights

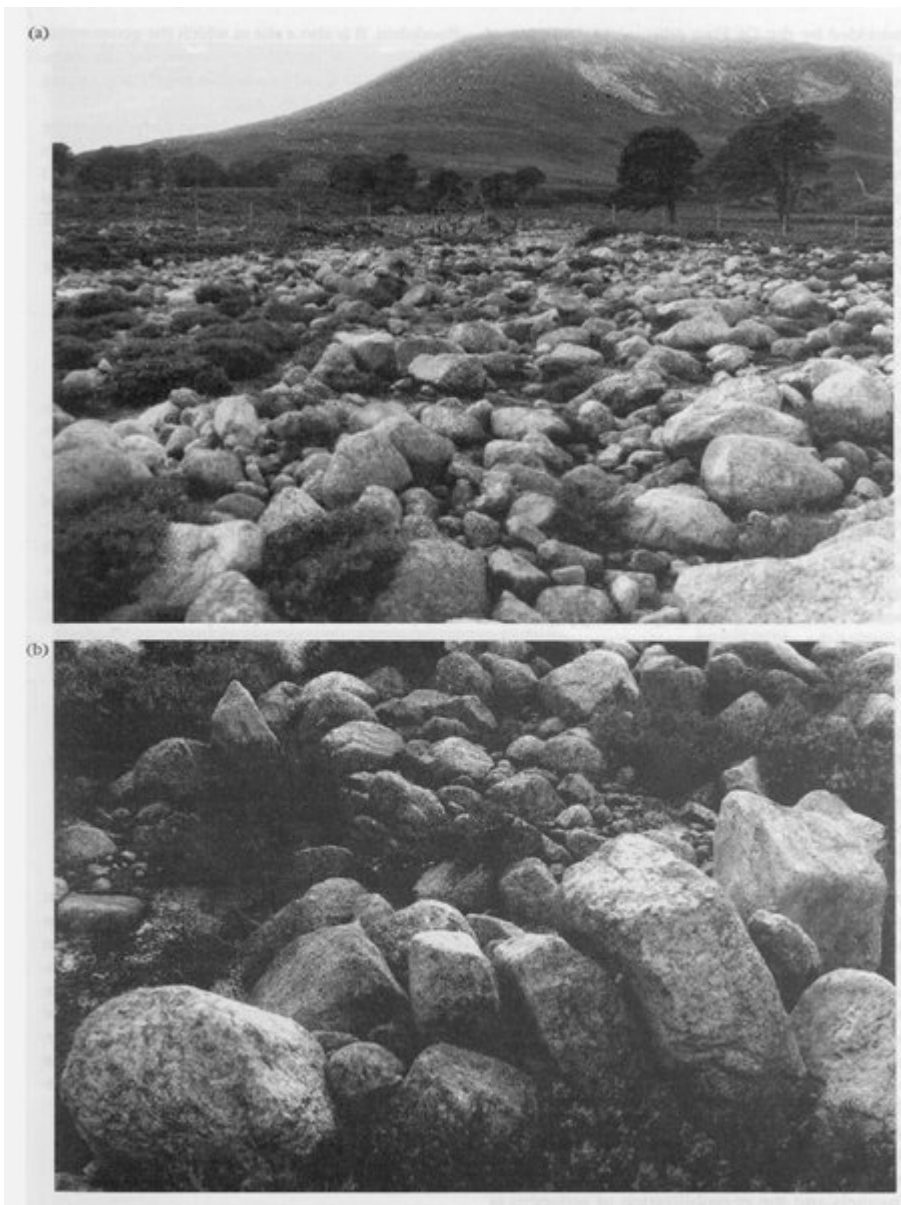
(Figure 2.37) Luibeg Burn. (a) Bouldery flood deposits (0.5–1.0 m b axes) reworked in the 1956 flood (flow direction towards camera). (b) A detail of the flood deposits, showing imbrication — flow direction right to left. (Photos: A. Werritty.)

Map and aerial photograph evidence over the period 1871–1956 indicate that this site remained relatively unaltered in its upper reaches, the geomorphic impact of the 1829 flood being the major imprint for the following century (McEwen, 1986). For example, major distributary channels, excavated to accommodate the extreme flood discharges, can still be identified. However, on 13–14 August 1956, an intense convective storm occurred with a 24 hour rainfall of 85.6 mm at Deny Lodge (estimated recurrence interval of 120 years; McEwen, 1986) and probably > 150 mm on higher ground (Baird and Lewis, 1957). The resulting flood had a very high competence, with the Parker Memorial Bridge being carried downstream and its supporting masonry piers overturned. The stream bed at the bridge more than doubled its width and heavy deposition was recorded with 'irregular fan-shaped deposits visibly raised above the general level of the neighbouring valley floor' (Baird and Lewis, 1957, p.97) downstream of this point. From aerial photographs, it appears that many of the old flood channels excavated during the 1829 flood were re-occupied and rescoured during this event.

Field survey has revealed a wide area of boulder deposition well above the competence of the normal river and spread out beyond the present channel, which is trenched within these deposits (McEwen, 1986). A large number of abandoned but well-defined flood channels are evident across this floodplain area. The present channel was clearly formed by a flow greatly in excess of normal flow conditions. The 1829 flood was therefore the main channel-forming event, with further excavation occurring during the 1956 flood. Median sediment size at the head of the reach was 70–120 mm, while estimated bankfull stream power at the head of the reach is in excess of  $1000 \text{ Wm}^{-2}$ . It should be noted that bankfull discharge has no implicit notion of frequency, as the cross-section clearly relates to low recurrence interval events. Through the designated reach, the channel gradient is reduced by virtually an order of magnitude (0.056–0.006). The site is particularly interesting as the flow required for re-occupation of the flood channels and the re-mobilization of sediment is extremely high. Normal to moderate flows have little geomorphic impact, both in terms of flushing sediment through the system and reworking the floodplain. It is also a site at which the geomorphic persistence of landforms formed by the catastrophic 1829 flood in a high-energy environment can continue to be recorded.
