# Upper River Severn between Dolwen and Penstrowed, Powys

[SN 996 851]–[SO 075 910]

R.D. Hey

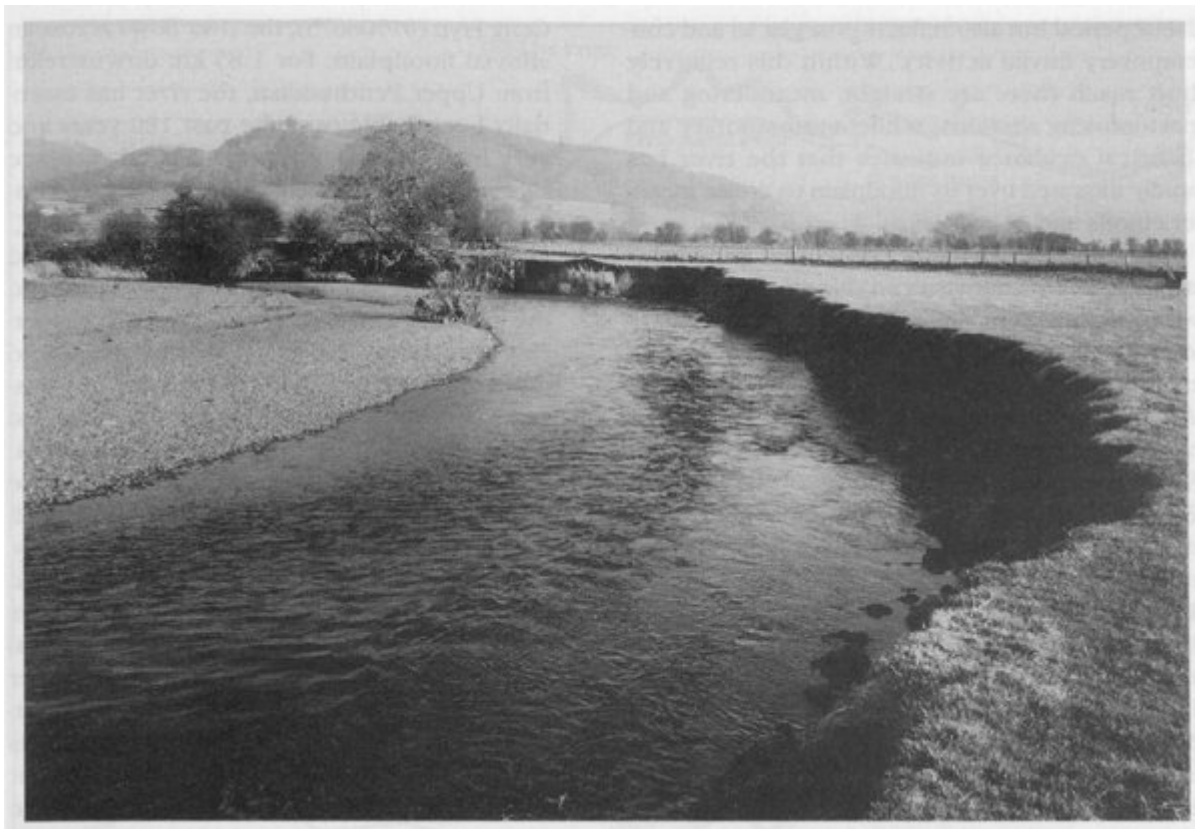
(Figure 3.29) The River Sever, at Caersws, showing active erosion of the outer bank of a meander, and deposition on the other. (Photo: S. Campbell.)

The reach is located in the piedmont zone between the relatively steep headwater reaches, which are zones of sediment production, and the less steep alluvial reaches downstream, which have reduced transport capacity. It is the reduced gradient that facilitates rapid bar accumulation, and associated bank erosion and changes in channel planform (Figure 3.29) and (Figure 3.30).

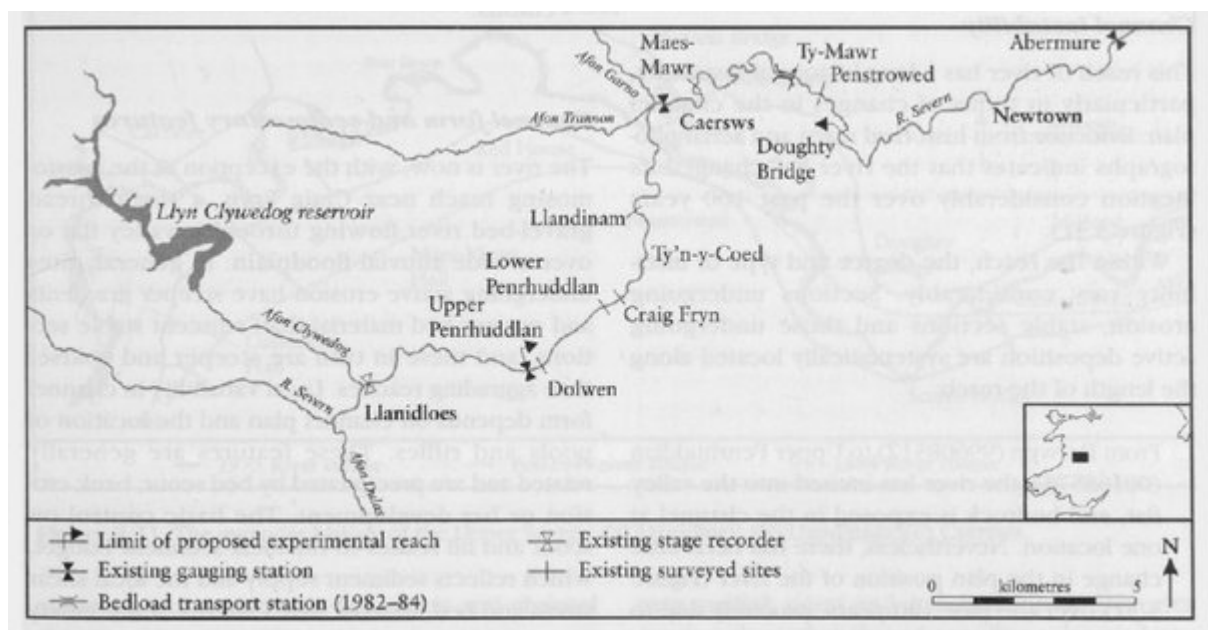
(Figure 3.30) A location map of the upper Sever, showing the positions of the measurement stations and survey sections.

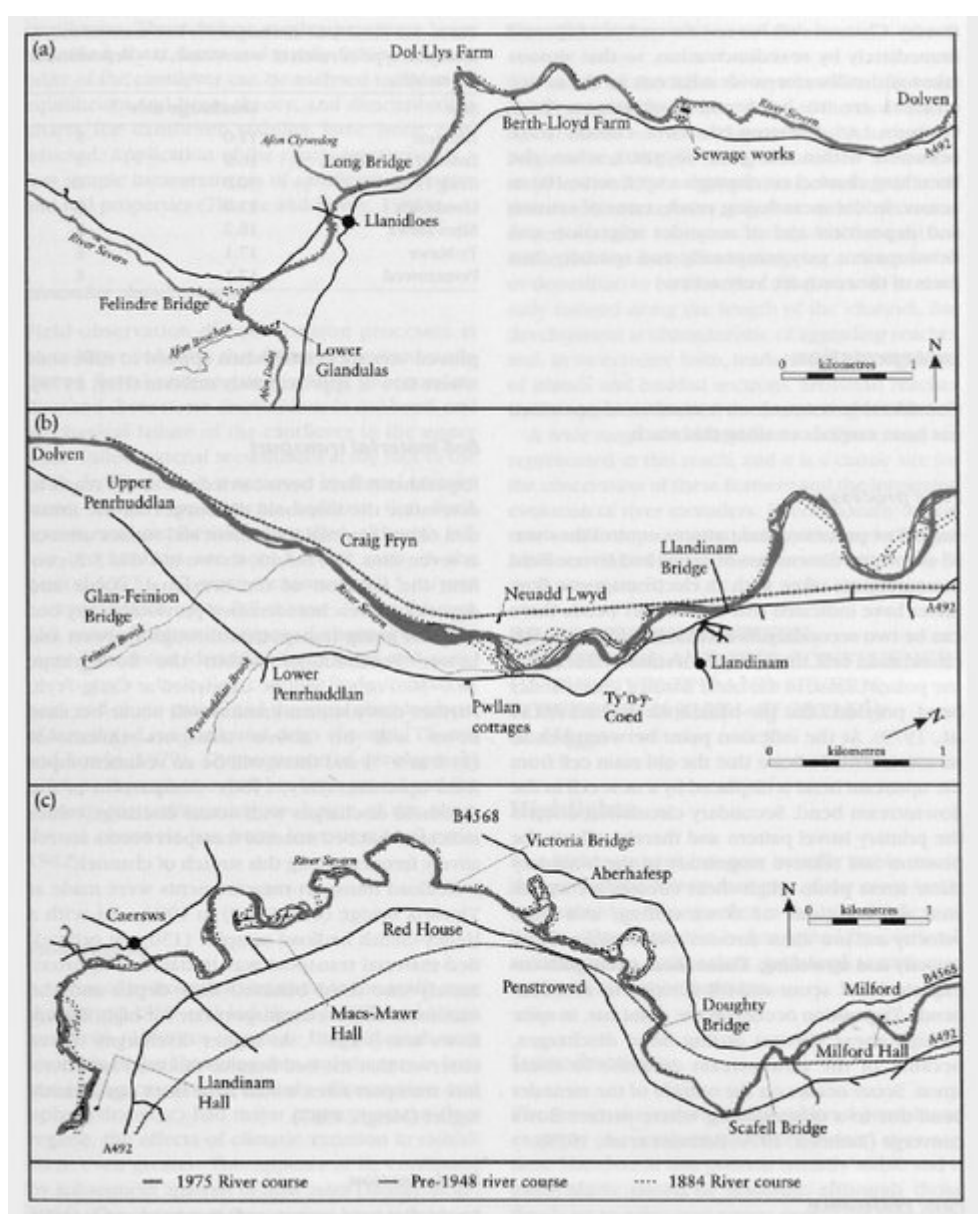
(Figure 3.31) The meander history of the Upper Severn: (a) Llanidloes; (b) Llandinam; (c) Caersws.

This reach of river has a long history of instability, particularly in terms of changes in the channel plan. Evidence from historical maps and aerial photographs indicates that the river has changed its location considerably over the past 100 years (Figure 3.31).

the river (Figure 3.31) over the past 100 years, probably due to the stabilizing influence of the bedrock outcrop and the presence of tree-lined banks.

2. Between Upper Penrhuddlan [SO 0016 8575] and Craig Fryn [SO 0150 8675], the river flows across an alluvial floodplain. For 1.85 km downstream from Upper Penrhuddlan, the river has essentially been stable over the past 100 years and very little lateral movement has taken place since it was straightened during railway construction in 1859 (Figure 3.31).

3. From Craig Fryn [SO 0150 8675] to Ty'n-y-coed [SO 0225 8780], the channel is very unstable and the position of the river has altered considerably over the last 100 years (Figure 3.31) due to rapid aggradation. The development of transverse bars and associated bank erosion has led to the creation of a braided channel system. Several islands have been formed which have since been vegetated by gorse and other small shrubs.
