EDC 25: Linn of Baldernock, Blairskaith

Site type: Artificial mine workings

Date visited: 9th March 2009

Summary description

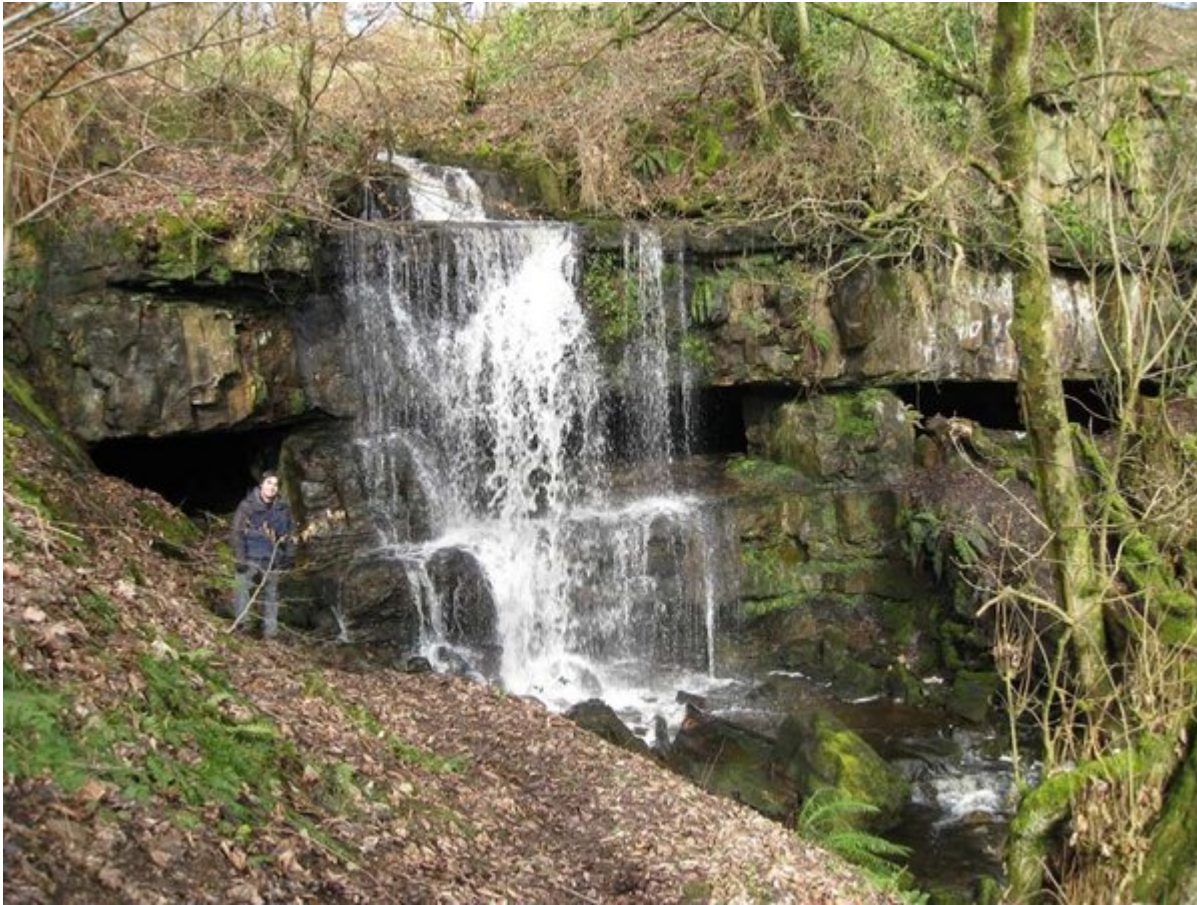
(Photo 145) Outcrops in the Branziet Burn show that microgabbro sills have intruded between the sedimentary rocks belonging to the Lower Limestone Formation forming a series of waterfalls, or 'linns'. The waterfall section displays a sub-horizontal sill at the top (approx 3m thick), beneath which are cavities from abandoned workings where the Baldernock Limestone has been mined. Underneath the limestone lie layers of sandstone, limestone and black shales. Looking NNE.

(Photo 145) Outcrops in the Branziet Burn show that microgabbro sills have intruded between the sedimentary rocks belonging to the Lower Limestone Formation forming a series of waterfalls, or 'linns'. The waterfall section displays a sub-horizontal sill at the top (approx 3m thick), beneath which are cavities from abandoned workings where the Baldernock Limestone has been mined. Underneath the limestone lie layers of sandstone, limestone and black shales. Looking NNE.

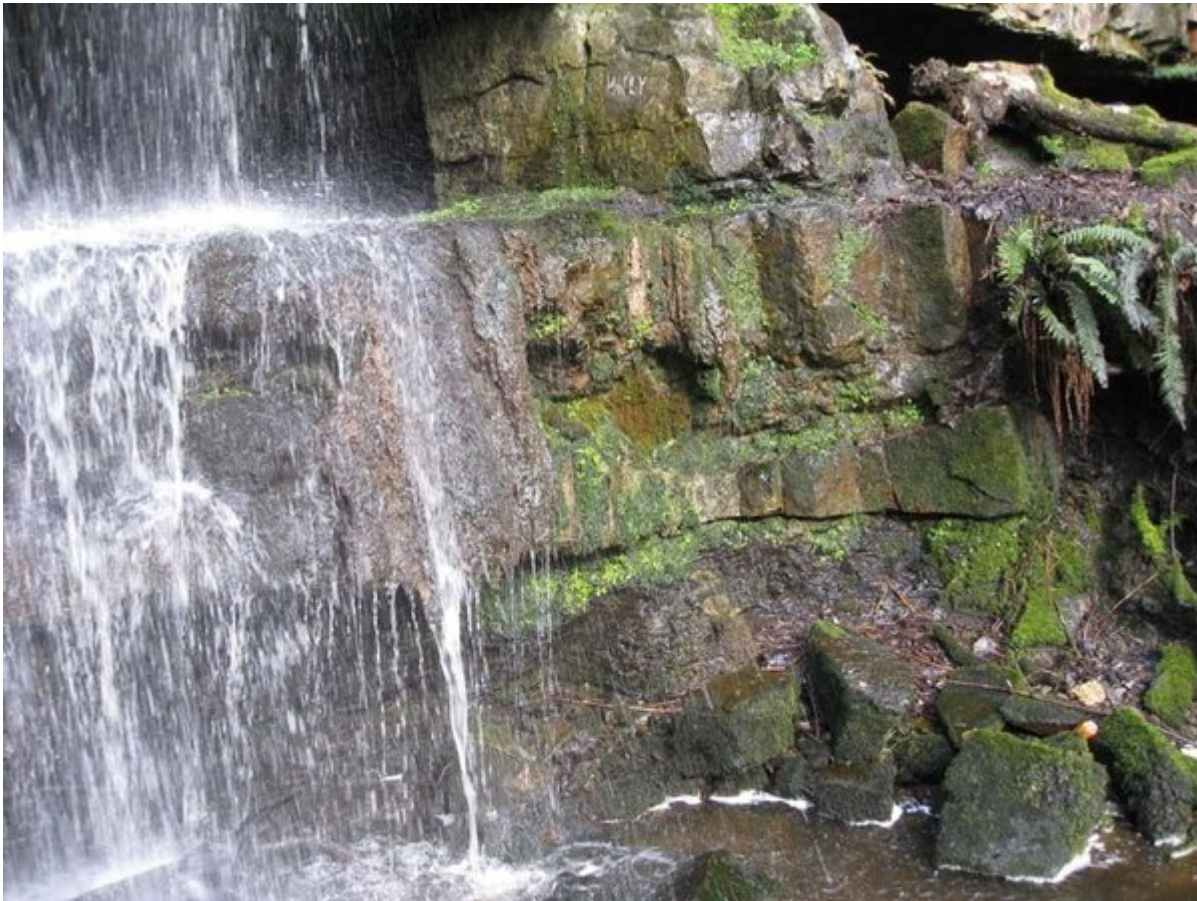
(Photo 146) Close-up of brown tufa deposits on the lower lip of the waterfall. Calcium carbonate deposits form as lime-rich waters plunge over a cliff. The water is aerated and carbon dioxide is released, resulting in the water becoming supersaturated with calcite which consequently precipitates as calcium carbonate onto the rocks below.

(Photo 146) Close-up of brown tufa deposits on the lower lip of the waterfall. Calcium carbonate deposits form as lime-rich waters plunge over a cliff. The water is aerated and carbon dioxide is released, resulting in the water becoming supersaturated with calcite which consequently precipitates as calcium carbonate onto the rocks below.

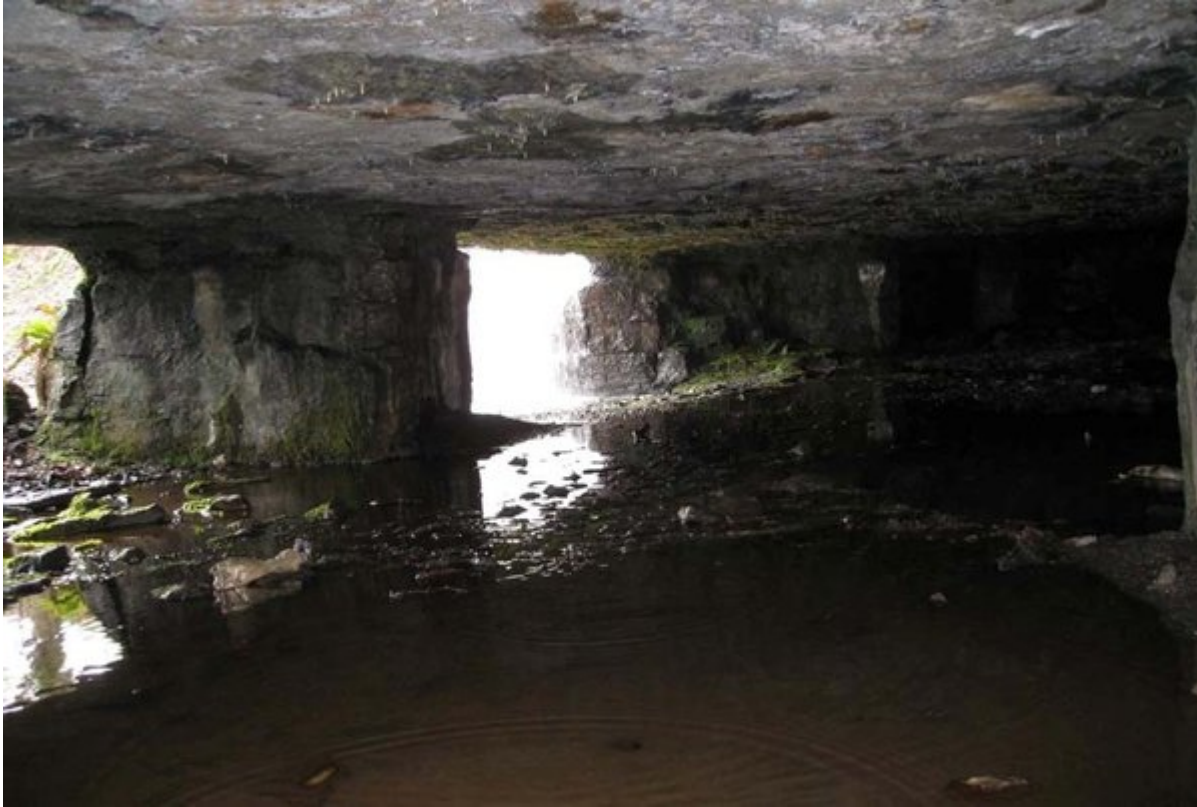
(Photo 147) View from inside the old 'stoop and room' workings located behind the waterfall. Limestone was an important resource in Central Scotland and even thin seams were often mined. The Baldernock Limestone is about 1-1.5m thick. The 'stoops' (pillars) supporting the roof can still be seen, while the limestone was extracted from the 'rooms'. The mine extends a short way beneath the sill and is well preserved, but wet and muddy underfoot. Entering the mine should not be encouraged.

(Photo 147) View from inside the old 'stoop and room' workings located behind the waterfall. Limestone was an important resource in Central Scotland and even thin seams were often mined. The Baldernock Limestone is about 1-1.5m thick. The 'stoops' (pillars) supporting the roof can still be seen, while the limestone was extracted from the 'rooms'. The mine extends a short way beneath the sill and is well preserved, but wet and muddy underfoot. Entering the mine should not be encouraged.

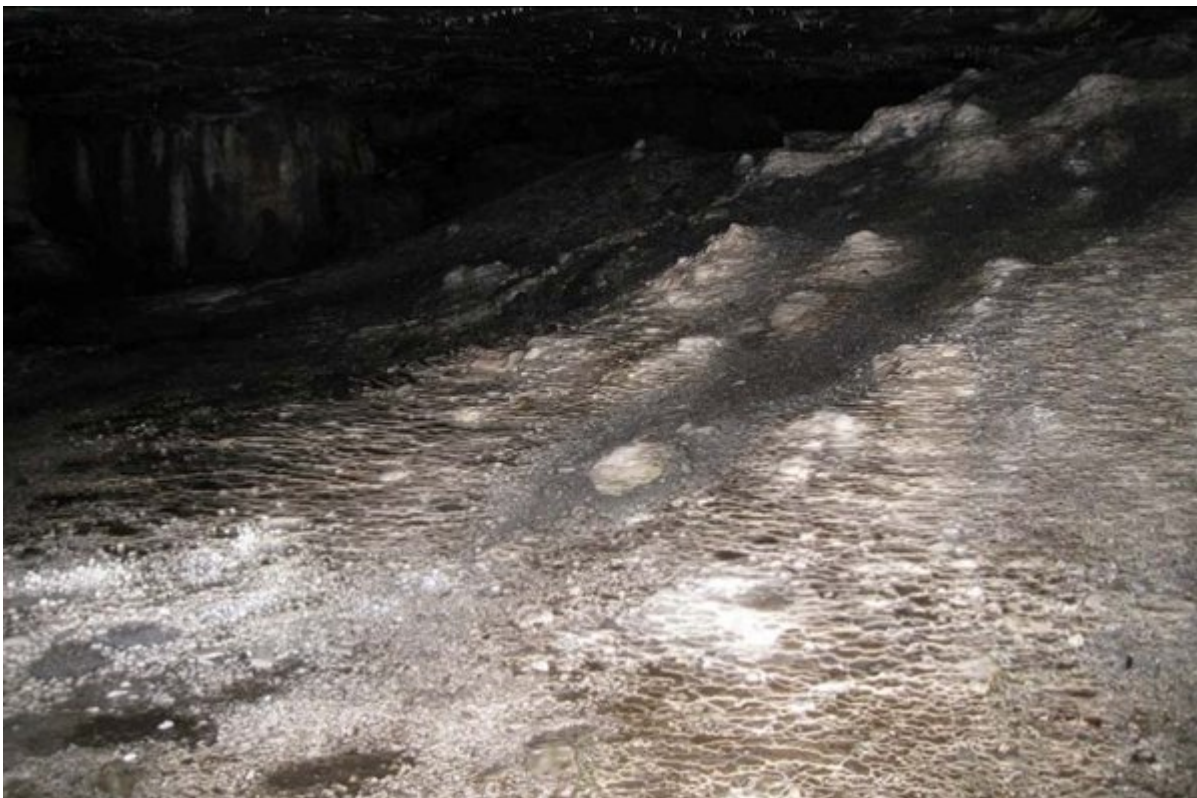
(Photo 148) View inside the limestone mine, showing a variety of cave formations or speleothems. These are formed as acidic water dissolves small amounts of limestone rocks, as it flows through cracks or joints into a cave. As the water comes into contact with the air, the carbon dioxide escapes and the water can no longer hold as much dissolved calcium. The excess calcium is precipitated on the cave walls, floor and ceiling. Speleothems form very slowly, taking around 50 years for 1cm of material. Examples of speleothems in the mine include stalactites, stalagmites, draperies, rimstone dams and cave pearls. Most of these features are at an early stage in their development and appropriate conservation must be applied to protect them.

(Photo 148) View inside the limestone mine, showing a variety of cave formations or speleothems. These are formed as acidic water dissolves small amounts of limestone rocks, as it flows through cracks or joints into a cave. As the water comes into contact with the air, the carbon dioxide escapes and the water can no longer hold as much dissolved calcium. The excess calcium is precipitated on the cave walls, floor and ceiling. Speleothems form very slowly, taking around 50 years for 1cm of material. Examples of speleothems in the mine include stalactites, stalagmites, draperies, rimstone dams and cave pearls. Most of these features are at an early stage in their development and appropriate conservation must be applied to protect them.

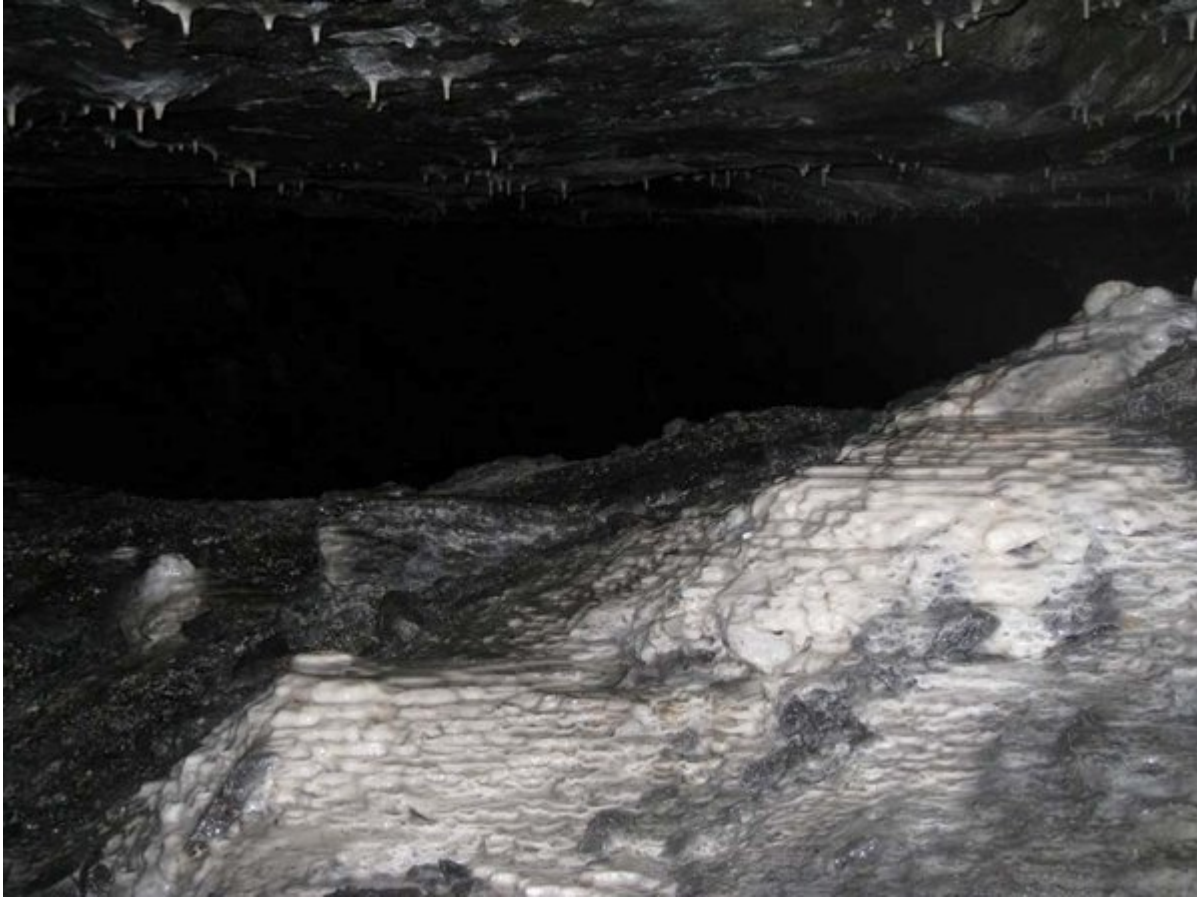
(Photo 149) Stalagmites are probably the best known cave formations. They are upward-growing mounds deposited as calcite is forced out of the water by agitation as a droplet hits the floor. Their shape is determined largely by drip rate, ceiling height, cave atmosphere conditions, and the carbonate chemistry of the drip water. Many stalagmites can be dated due to the presence of naturally occurring radioactive isotopes which has allowed dating of associated paleontological and archaeological finds, as well as holding a record of past climates.

(Photo 149) Stalagmites are probably the best known cave formations. They are upward-growing mounds deposited as calcite is forced out of the water by agitation as a droplet hits the floor. Their shape is determined largely by drip rate, ceiling height, cave atmosphere conditions, and the carbonate chemistry of the drip water. Many stalagmites can be dated due to the presence of naturally occurring radioactive isotopes which has allowed dating of associated paleontological and archaeological finds, as well as holding a record of past climates.

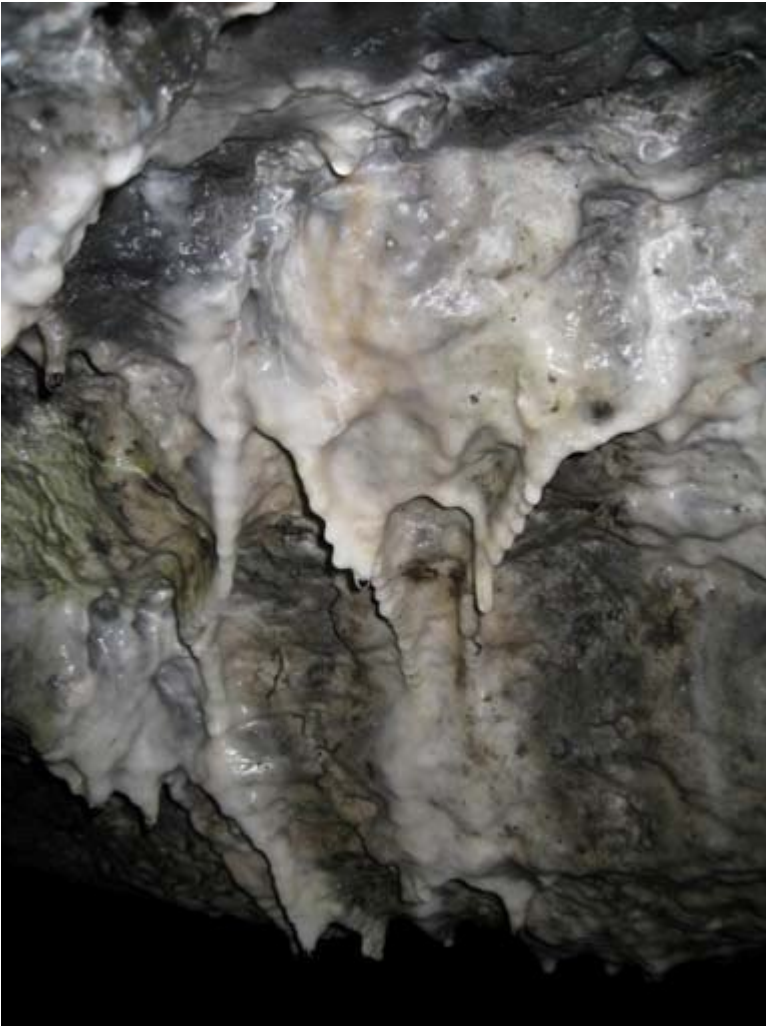
(Photo 150) 'Draperies' can be seen on some overhanging surfaces in the mine where surface tension has allowed calcite-rich solutions to cling to a wall or sloping ceiling as they stream slowly downward. The supersaturated solutions deposit a thin trail of calcite, which, hanging slightly lower than the surrounding surface, becomes a preferential route for continued flow, and so develops into slender, delicate sheets.

(Photo 150) 'Draperies' can be seen on some overhanging surfaces in the mine where surface tension has allowed calcite-rich solutions to cling to a wall or sloping ceiling as they stream slowly downward. The supersaturated solutions deposit a thin trail of calcite, which, hanging slightly lower than the surrounding surface, becomes a preferential route for continued flow, and so develops into slender, delicate sheets.

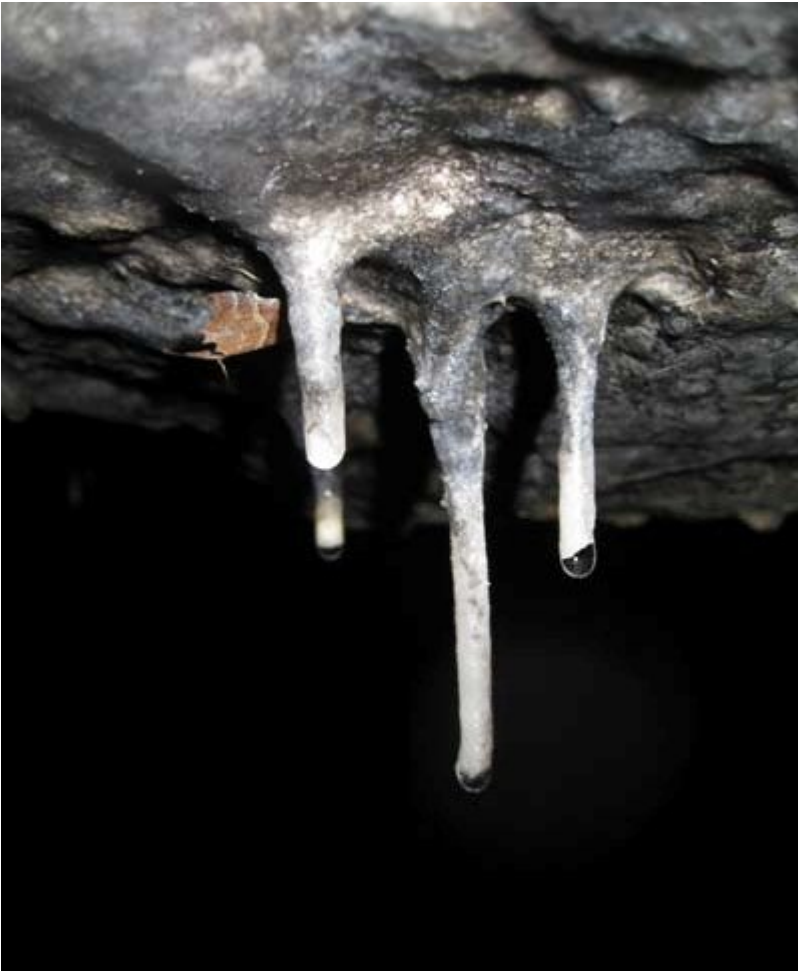
(Photo 151) Delicate 'soda straws' can be found hanging from much of the mine roof. They have formed as water seeps down from the surface and drops to the floor, leaving a tiny deposit of dissolved calcite on the ceiling. This deposit is in the shape of a ring which, as more water droplets come through, forms a small, hollow tube which hangs from the ceiling. In time, this will develop into a much larger stalactite.

(Photo 151) Delicate 'soda straws' can be found hanging from much of the mine roof. They have formed as water seeps down from the surface and drops to the floor, leaving a tiny deposit of dissolved calcite on the ceiling. This deposit is in the shape of a ring which, as more water droplets come through, forms a small, hollow tube which hangs from the ceiling. In time, this will develop into a much larger stalactite.

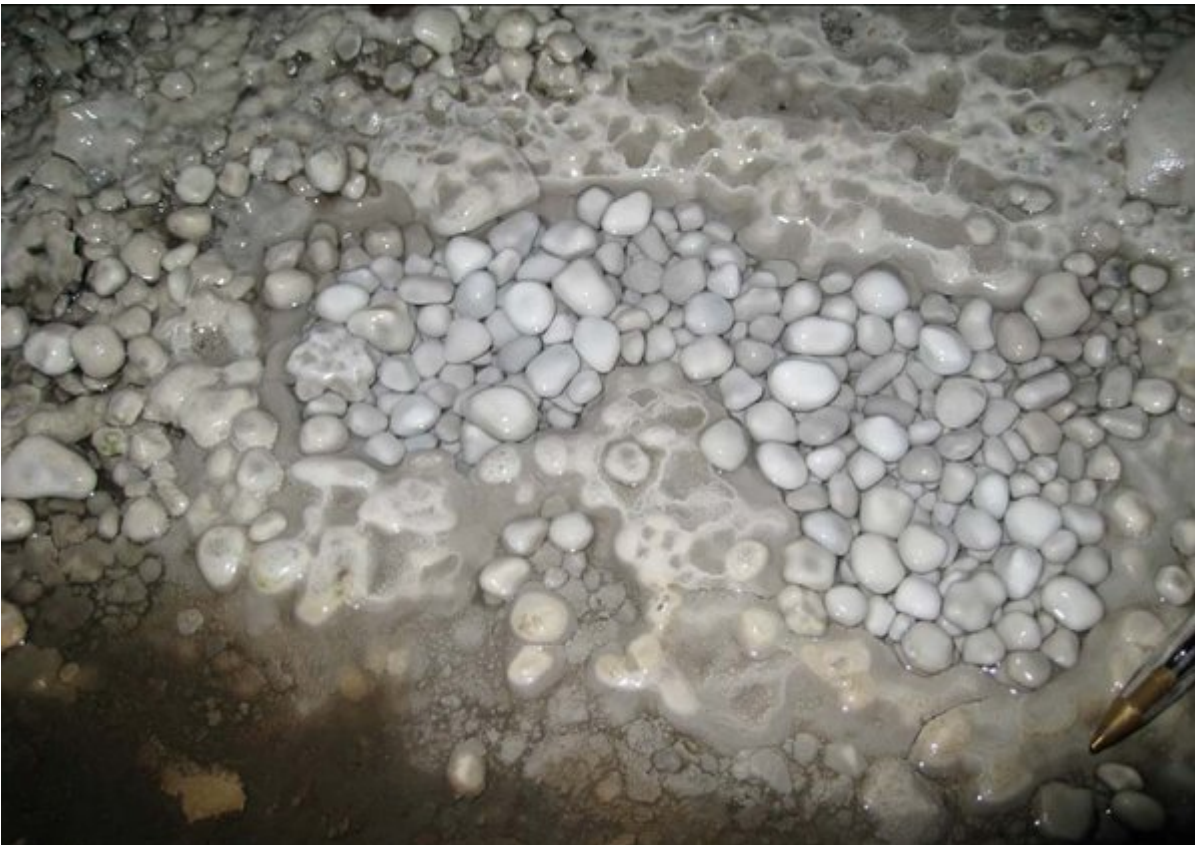
(Photo 152) A rare and beautiful example of a cave pearl nest. 'Cave pearls' are concretions found in shallow cave pools, which form when water dripping into the pool loses carbon dioxide and precipitates calcite. Unusually, these pearls are not cemented onto the pool floor, which may be due to vibrations in the pool caused by the dripping water. Excess precipitate has formed a cup or nest around the pearls.

(Photo 152) A rare and beautiful example of a cave pearl nest. 'Cave pearls' are concretions found in shallow cave pools, which form when water dripping into the pool loses carbon dioxide and precipitates calcite. Unusually, these pearls are not cemented onto the pool floor, which may be due to vibrations in the pool caused by the dripping water. Excess precipitate has formed a cup or nest around the pearls.

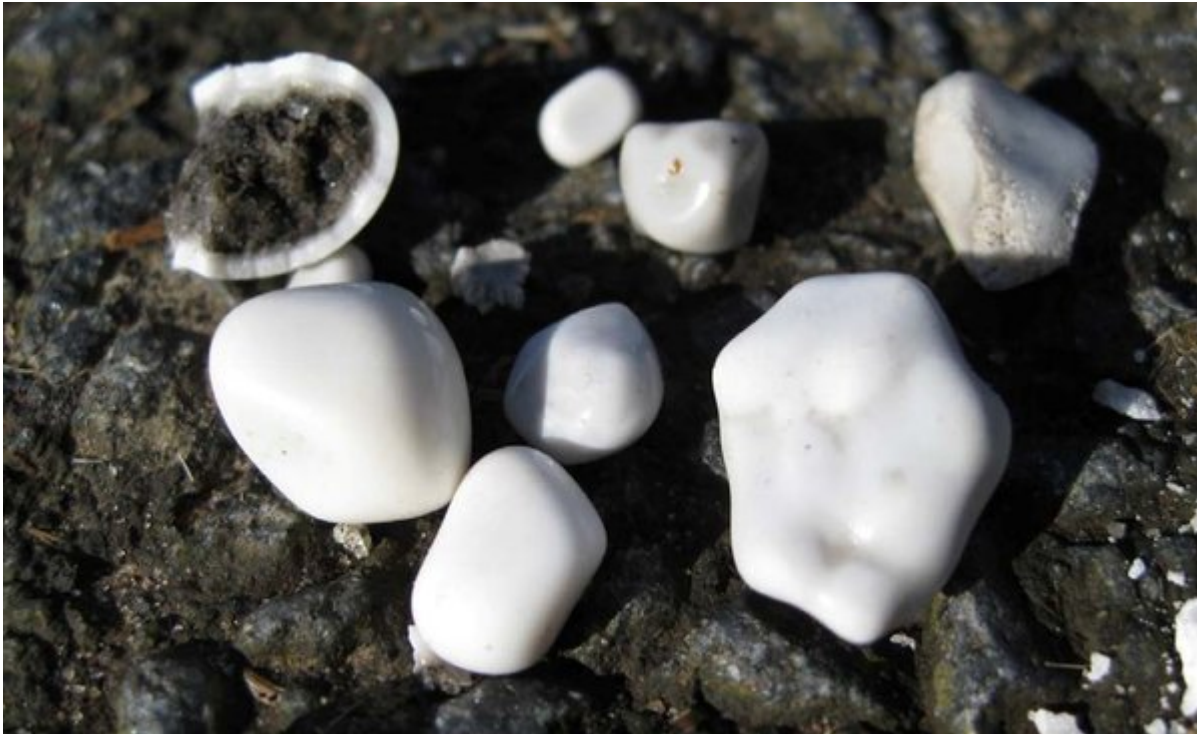
(Photo 153) The shape, size and colouring of cave pearls differs from one cave to another. However, they all have a similar concentric internal structure, which is formed as calcite continuously precipitates around a nucleus. The 'pearls' collected in the mine appear to have a piece of dark-coloured gravel at their core which is surrounded by white calcite. These examples are between 0.5cm and 2cm in diameter. The roundness typical of cave pearls is due to the uniform growth of the pearl.

(Photo 153) The shape, size and colouring of cave pearls differs from one cave to another. However, they all have a similar concentric internal structure, which is formed as calcite continuously precipitates around a nucleus. The 'pearls' collected in the mine appear to have a piece of dark-coloured gravel at their core which is surrounded by white calcite. These examples are between 0.5cm and 2cm in diameter. The roundness typical of cave pearls is due to the uniform growth of the pearl.

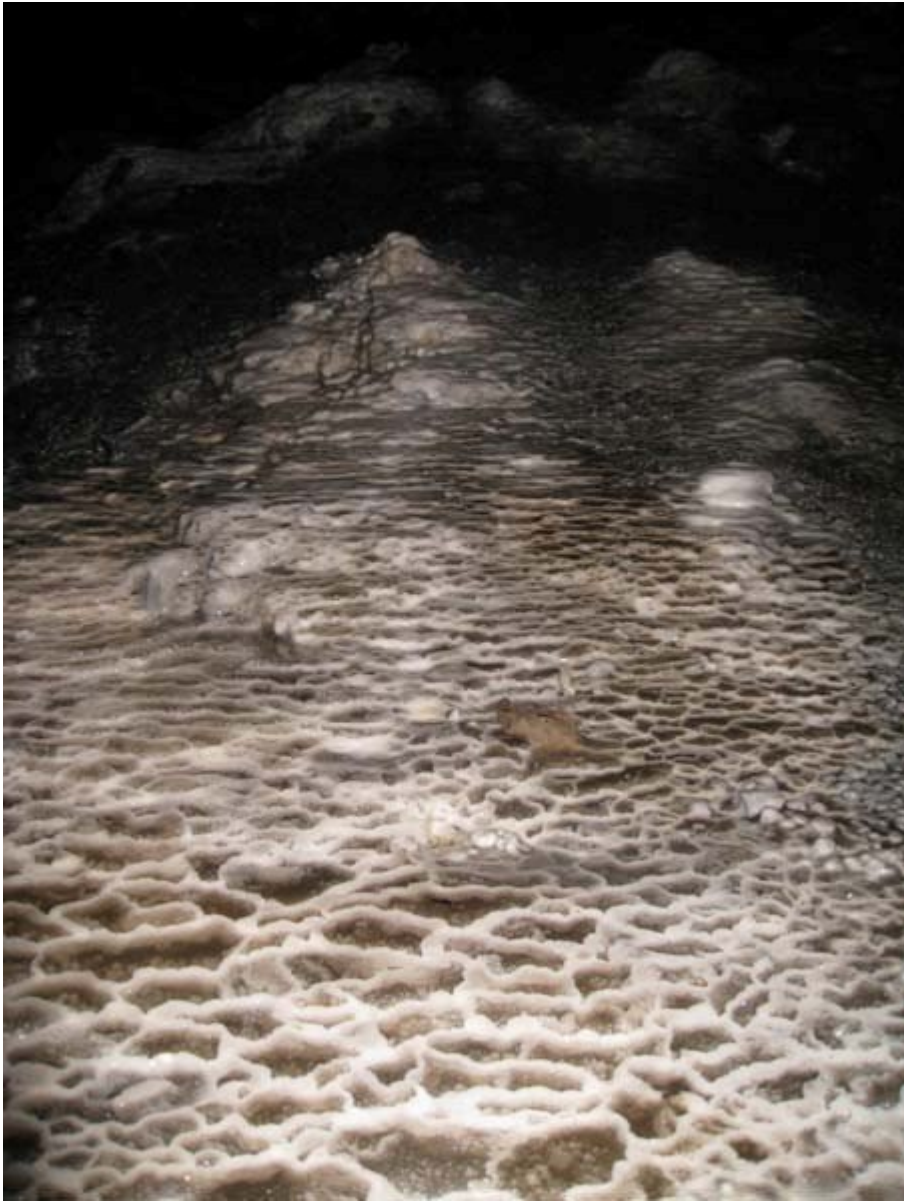
(Photo 154) Superb examples of rimstone dams (or gours). These are mineral barriers, usually of calcite which pond streams or shallow pools in caves.

(Photo 154) Superb examples of rimstone dams (or gours). These are mineral barriers, usually of calcite which pond streams or shallow pools in caves.

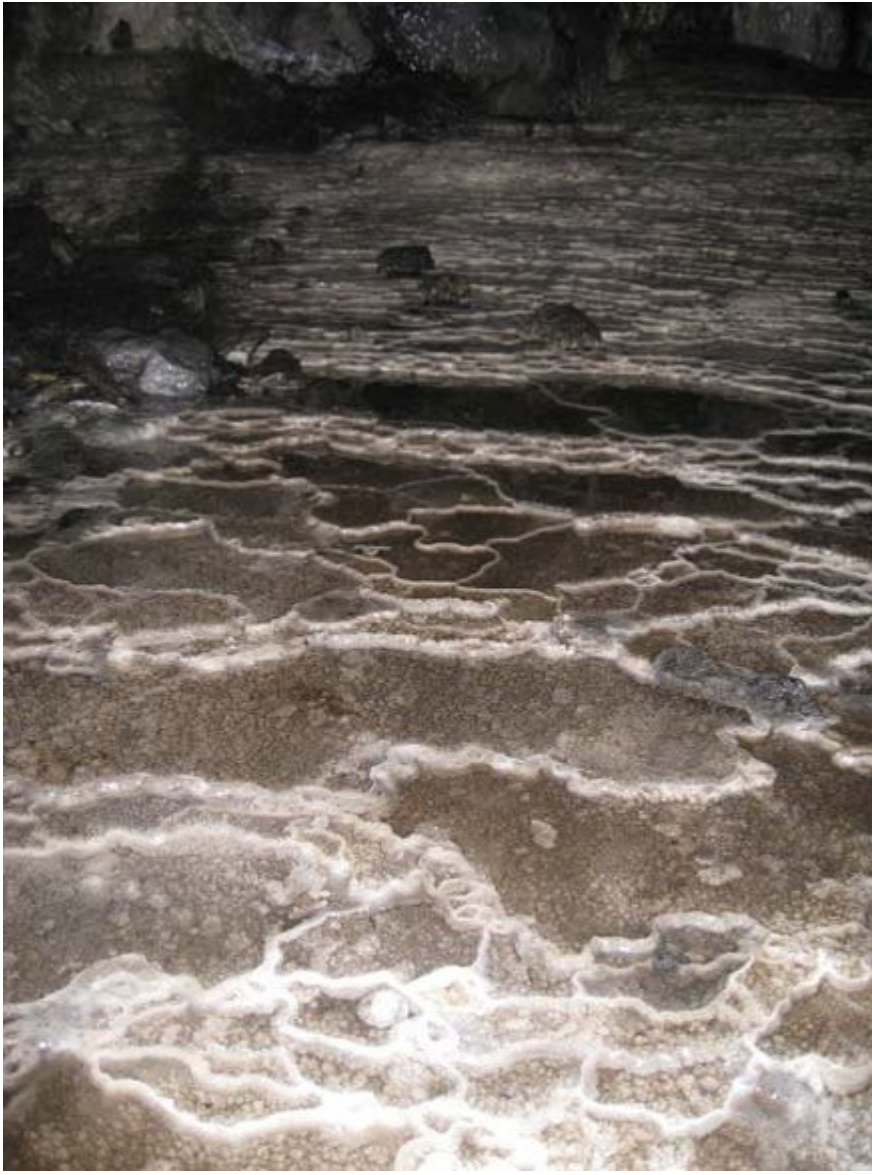
(Photo 155) Rimstone dams usually form where there is a slope underground with a flow of water, which creates a series of steps or terraces over the surface, or can form many tiny micro-gours on horizontal surfaces.

(Photo 155) Rimstone dams usually form where there is a slope underground with a flow of water, which creates a series of steps or terraces over the surface, or can form many tiny micro-gours on horizontal surfaces.

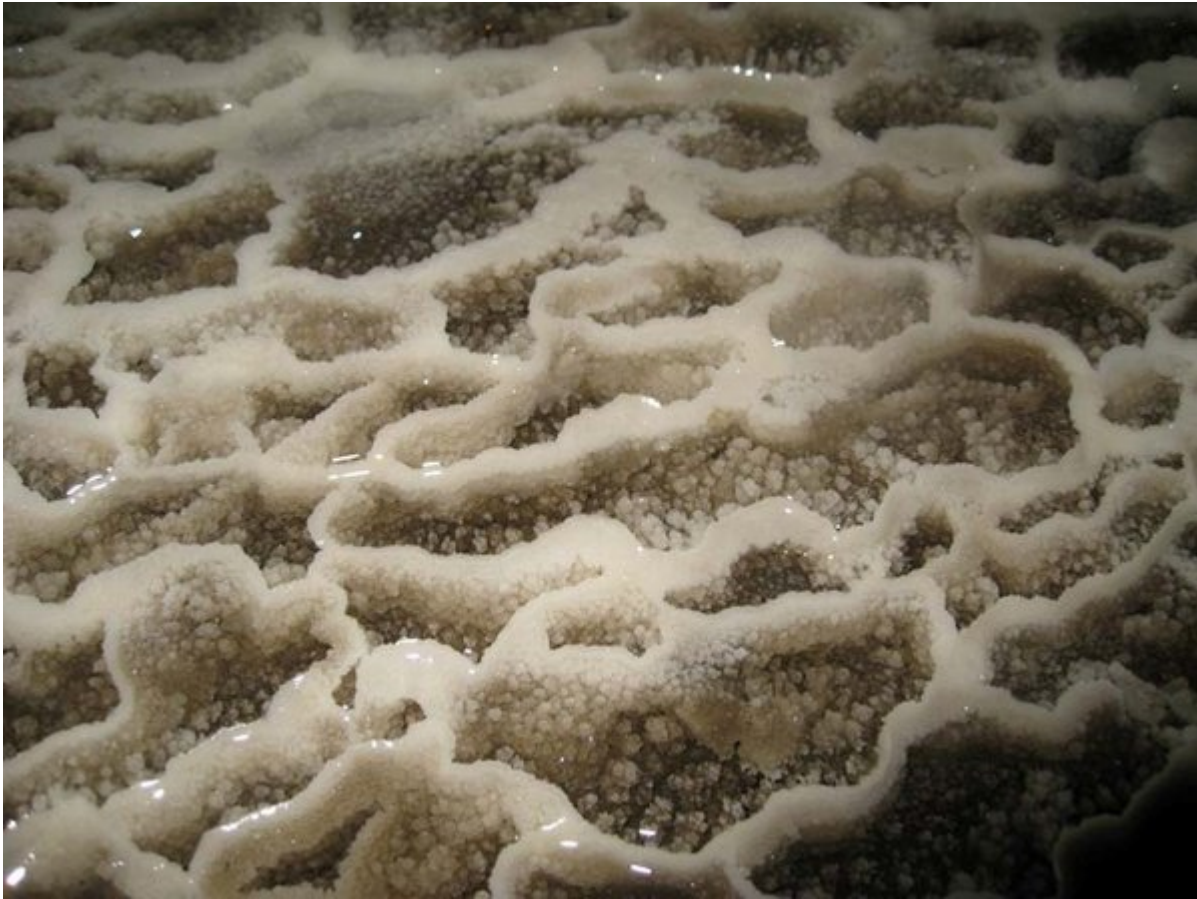
(Photo 156) Crystallization of a gour begins to occur at the air/water/rock interface. The turbulence caused by flow over the edge of the ridges may contribute to the outgassing or loss of carbon dioxide from water, resulting in precipitation of mineral on this edge.

(Photo 156) Crystallization of a gour begins to occur at the air/water/rock interface. The turbulence caused by flow over the edge of the ridges may contribute to the outgassing or loss of carbon dioxide from water, resulting in precipitation of mineral on this edge.
