ELC_29: Gullane Bents

Site information

Gullane Bents is a 2km long stretch of sand dunes and beach located to the west of the town. It is of geomorphological interest as an applied case study of sand dune restoration following extensive disturbance.

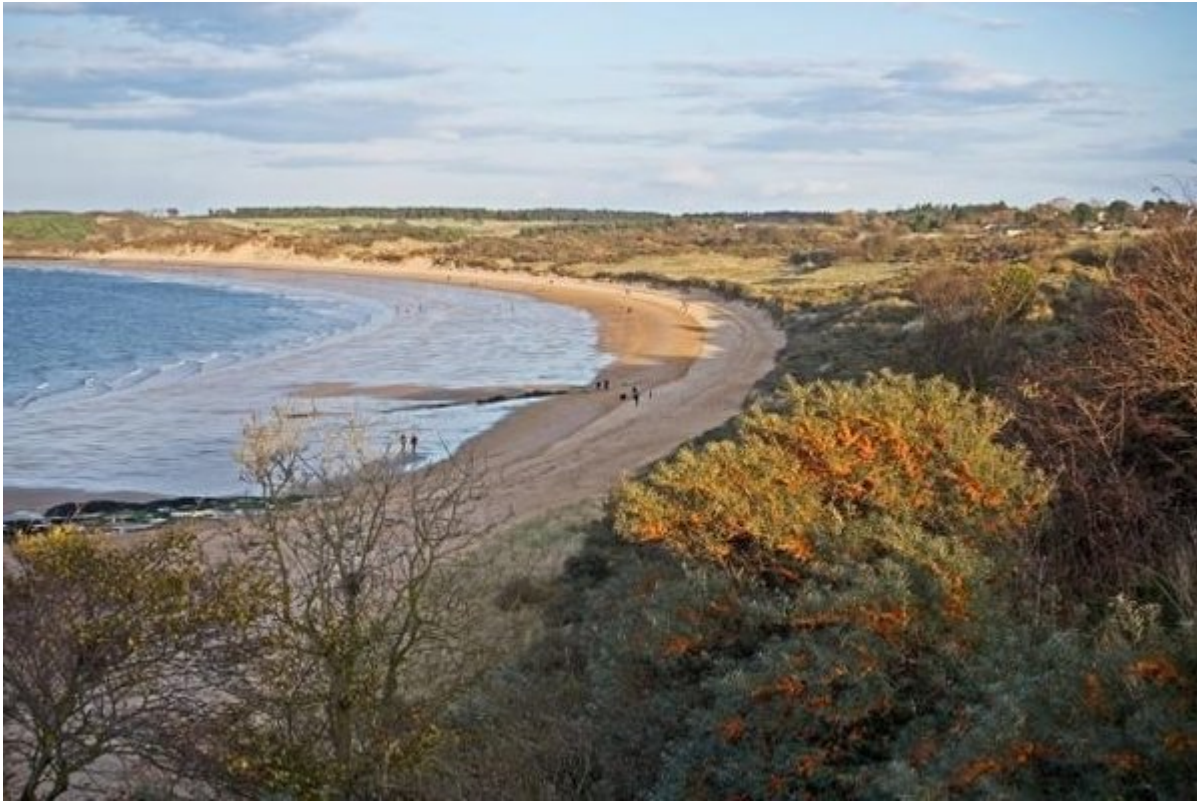
(ELC_29_P1) Gullane Beach and Bents: view from the south-west, showing erosion of much of the coastal edge and a small area of accretion at the back of the beach in the foreground. © John Gordon.

The site comprises an area of sand dunes and beach on the north-west side of Gullane. The dunes overlie a raised beach with a backing cliff inland (ELC_29_P1), (ELC_29_P2). Prior to World War 2, the area was heavily used for recreation and sand extraction. During the War, the beach and dunes were used for military exercises. Consequently, there was a high human impact, with extensive areas of bare sand and sand blowing landwards. During the 1960s, the Council implemented a rehabilitation plan that included the re-creation of the foredune ridge, use of fences to trap sand and planting of marram grass and sea buckthorn to stabilise bare sand areas and sources of blowing sand in the westernmost dunes. As part of the works, the foredune was bulldozed and re-profiled.

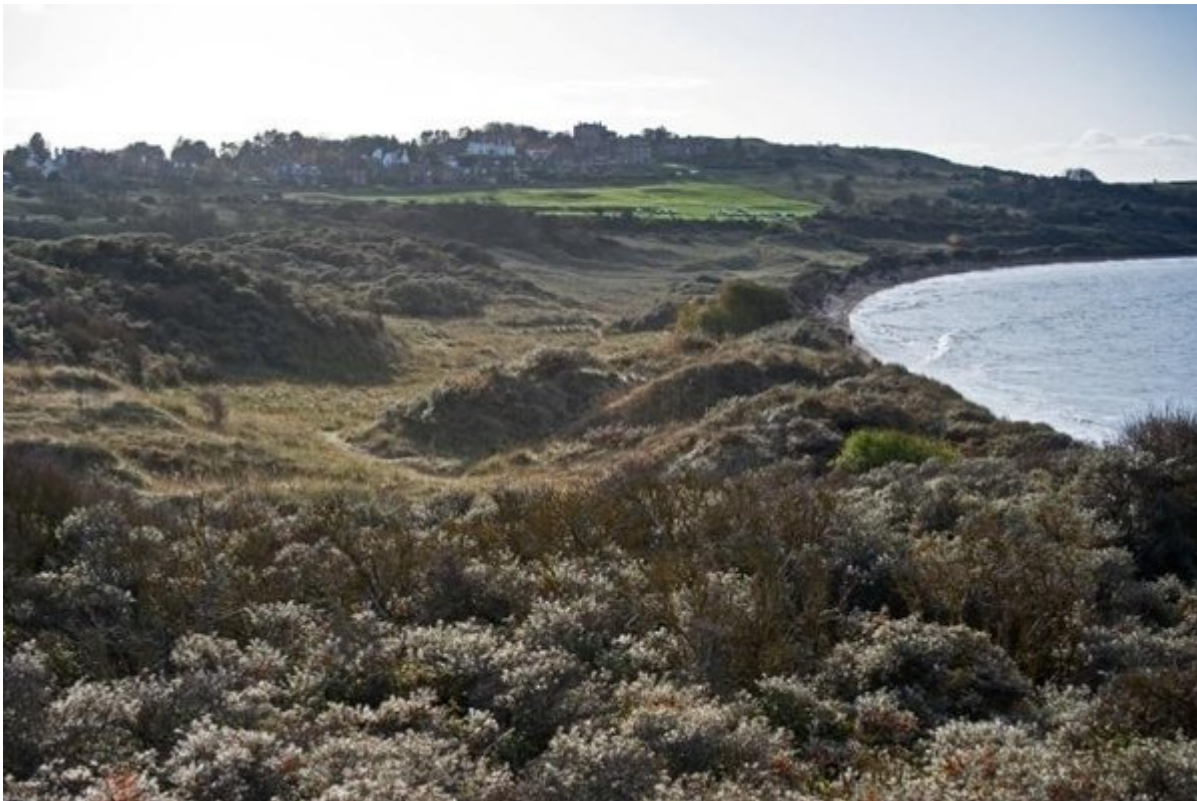
(ELC_29_P2) Gullane Bents: view from the north-east showing the foredune ridge, dune slack and climbing dunes on the backing cliff © John Gordon.

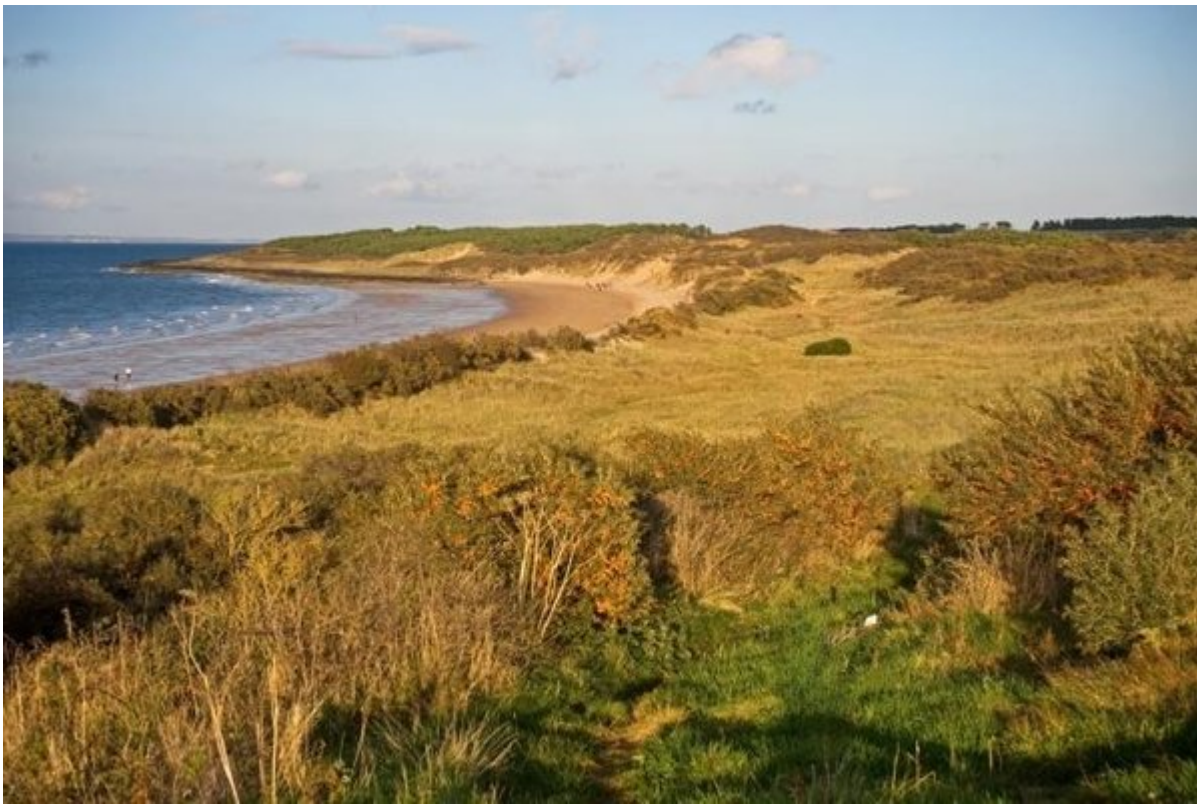
(ELC_29_P3) Gullane Bents: view from the car park, showing the foredune ridge, dune slack and area of high dunes to the north-east. © John Gordon.

A detailed description of the geomorphology of Gullane Bents is provided by Rose (1980). The central part of the bay is fronted by a single low foredune ridge with a duneslack behind, then an area of climbing dunes on the backing cliff. A zone of more complex high dunes occurs to the north-east (ELC_29_P3).

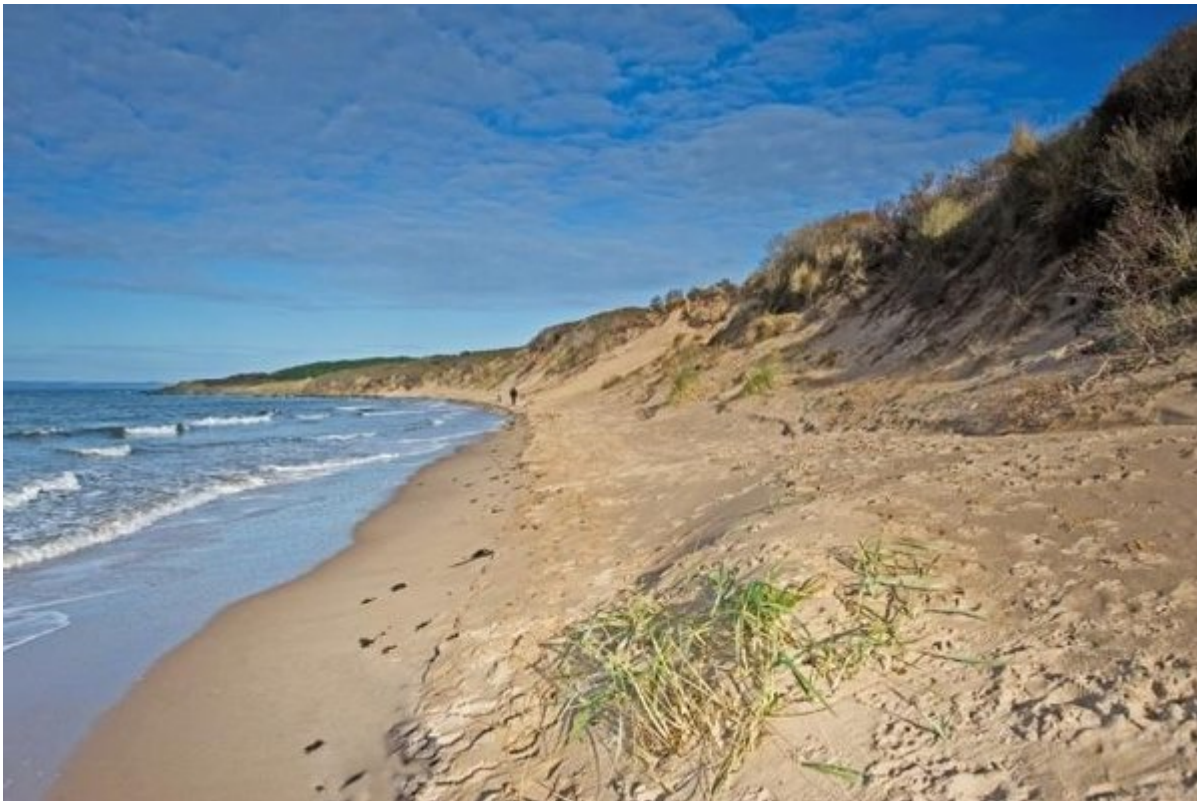
Along much of the length of the bay, apart from the western end, the coastal edge of the foredune ridge is currently undercut by the sea, particularly in winter, with collapse of sea buckthorn plants down the seaward face, a similar situation to that noted by Rose in 1980 (ELC_29_P4), (ELC_29_P5). Behind the dunes, a bare sand plain in 1980 has become stabilised. The foredune ridge is relatively low in places, with local washovers occurring during winter 2013–2014 (ELC_29_P5), (ELC_29_P6), and may be vulnerable to future breaching under a combination of sea-level rise and storm surge conditions.

(ELC_29_P4) Eroding coastal edge. © John Gordon.

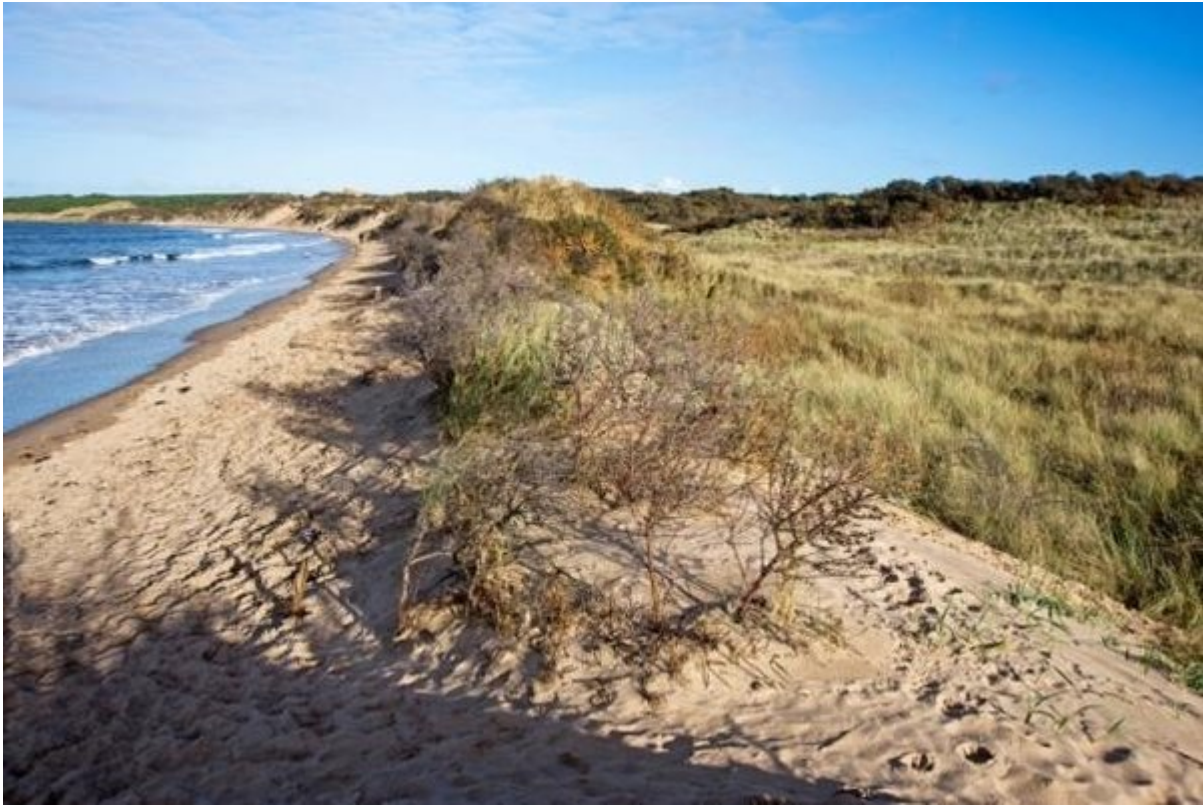
(ELC_29_P5) Washover of the foredune ridge. © John Gordon.

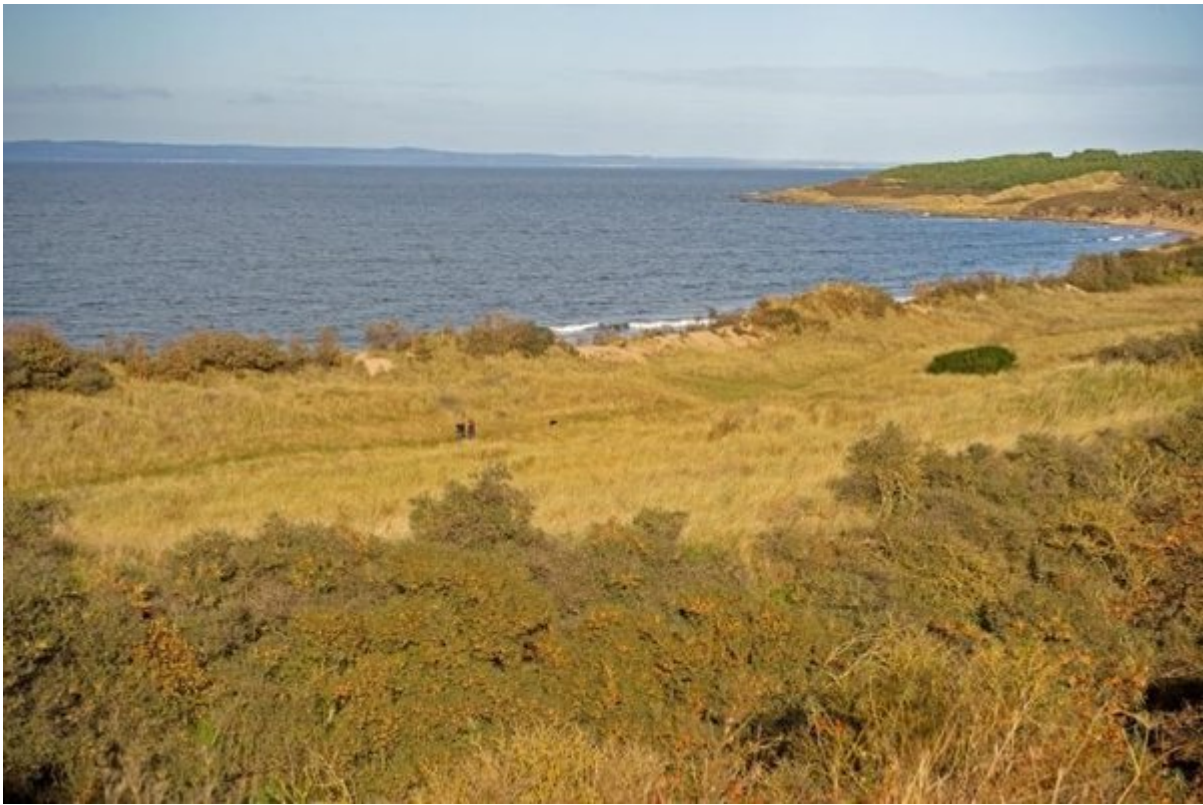
(ELC_29_P6) Washover areas along the foredune ridge. © John Gordon.
