# Allt Mor (River Nairn), Highland

[NH 635 235] and [NH 635 265]

L.J. McEwen and A. Werritty

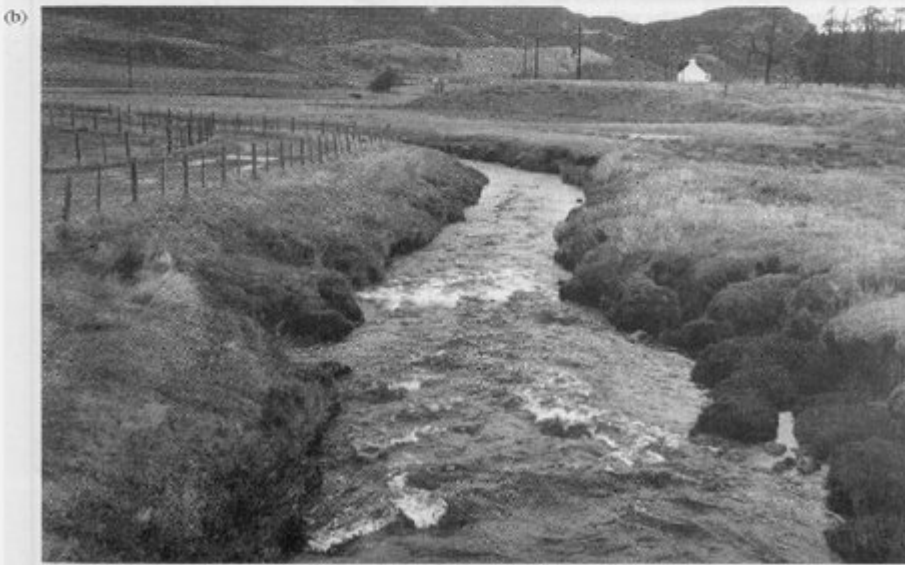
*(Figure 2.38) Allt Mor (River Nairn). (a) The upper reach, boulder-bed mountain torrent, highly divided flow around unstable bars. (b) The lower reach, stable sinuous channel in Strath Nairn. The two reaches are only 2 km apart, illustrating the 'discordance' and rapid change in channel morphology. (Photos: L J. McEwen.)*

The headwaters of the River Nairn drain the middle part of the Monadhliath Mountains in the northern Grampians. These mountains are formed from Moinian schists overlain by a cover of glacial sediments locally in excess of 10 m thick. The river rises to the west of Carn Ghriogair (805 m), flows to the north-west and reaches the main valley at the point at which it passes under the B851 road. Within a few kilometres of this location the river has undergone a metamorphosis from a straight, steep, coarse-grained and unstable channel (Figure 2.38)(a) to a narrow, incised, meandering and stable channel (Figure 2.38)(b).

In its upper reaches the Allt Mor is a boulder-bed mountain torrent 9–10 m wide, with a  $D_M$  of bed material around 700 mm, and a slope of 0.08. Typical width : depth ratios are 12–13 and the channel is often multi-thread at low flow and slightly sinuous (Steel, 1984). Like its namesake in Glenmore (McEwen and Werritty, 1988), the upper Allt Mor is entrenched for much of its course within glacial and glaciofluvial deposits (Figure 2.39). These are locally subject to rapid mass-wasting on account of slope failures caused by basal undercutting by the Allt Mor during major floods (e.g. September 1981). The pattern of failures often conforms to the so-called 'pseudo-meandering' observed in laboratory experiments (Hickin, 1969), where the focus of undercutting alternates down the channel. Once a major slope failure has been initiated it typically becomes further enlarged by frost heave, surface wash and rilling (cf. the processes operating at Allt a' Choire), thereby generating a steady supply of sediment from the slopes on to the valley floor. However, not all of the valley floor is reworked during a major flood; nor are all the adjacent slopes, many of which are stable and vegetated, potential sites for slope failure. Boulderly lobes of coarse flood deposits are also found above the general level of the valley floor in the uppermost reaches of the channel.

On reaching the main valley floor of Strath Nairn, the river undergoes a metamorphosis. Downstream of Tyrich river channel training ceases, and the hydraulic geometry of the channel now becomes that of the typical lowland, inactive meandering river (Figure 2.38)(b). Thus the width is 7 m, the width : depth ratio has become 5–6 and the gradient reduced to  $< 0.005$ . The  $D_{84}$  of the bed material is 20–40 mm, and the % silt-clay content in the banks is around 15–25%. The channel has not increased its cross-sectional area commensurate with the increase in drainage area, with the result that overbank floods are common. For the next 20 km the River Nairn provides a good example of an 'underfit' stream, i.e. a stream the present size of which is disproportionate to the size of the valley in which it flows (Dury, 1964).
