Derry Burn, Aberdeenshire

L J. McEwen

Highlights

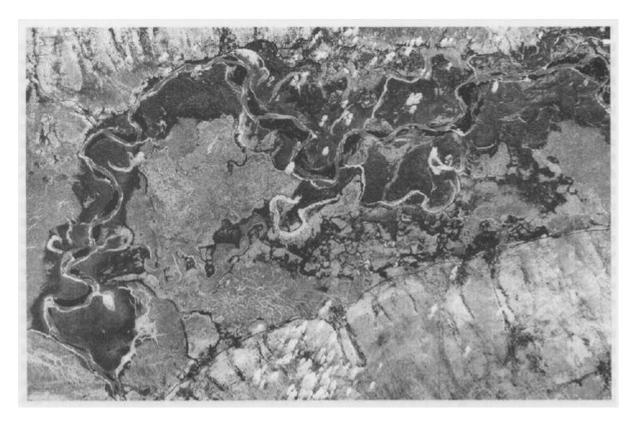
(Figure 2.19) Derry Burn: a downstream reach displaying tortuous meanders and numerous abandoned channels. The alluvial basin is terminated by a bedrock control (to the bottom left of the photograph). (Photo: Royal Commission on the Ancient and Historical Monuments of Scotland; print 4188, 106G/SCOT/UK/58: Crown Copyright.)

Upstream, the channel is a wandering gravel-bed river with local division. With downstream variation in controls, the channel displays a number of planform types, ranging from a sinuous channel through to irregular and tortuous meanders. The planform controls (i.e. sediment size, sediment availability and channel slope) all vary downstream. Sediment size (D_{50}) in the lower reaches ranges from 16 to 33 mm, while the slope is 0.005–0.007. The sediment is derived from the alluvial basin as the river reworks the surficial deposits, with a locally restricted base level imposed by the lower bedrock section (at the downstream end of the site). Large numbers of palaeochannels, especially tortuous meander neck cutoffs, frequently with standing water, indicate extensive past reworking of the floodplain. These are evident from map, aerial photograph and field evidence (Figure 2.19).
